Case study: Corroglass 600 for riser pipes

Seawater pump riser pipes maintained after 21 years.

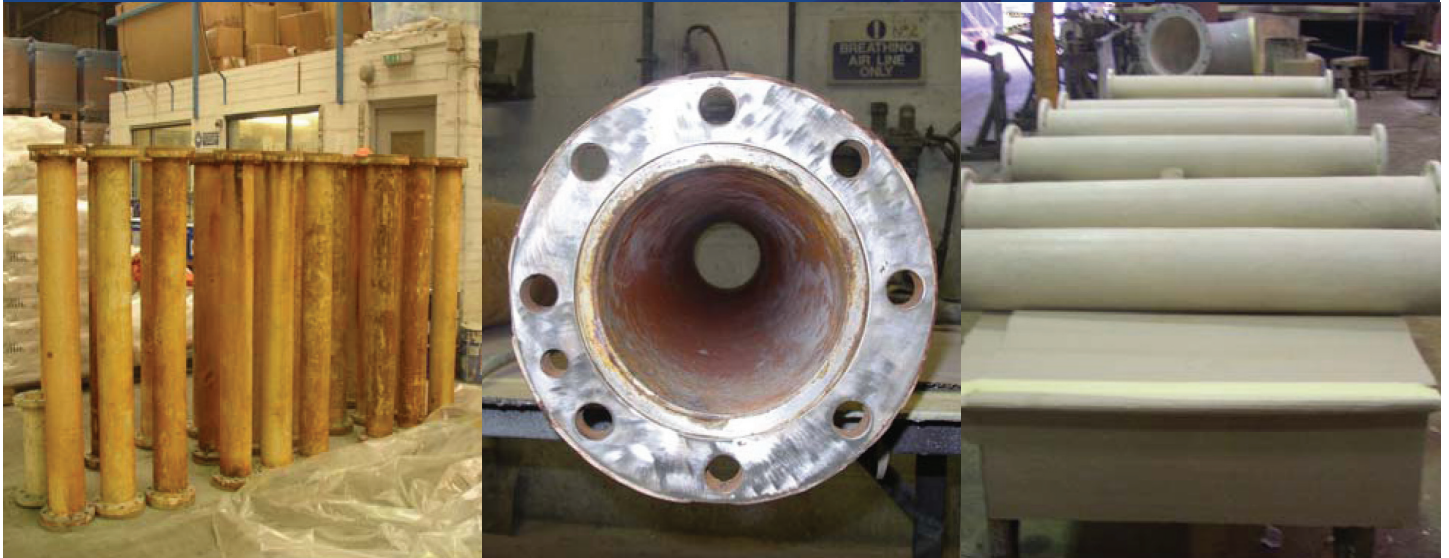
During the service life, which comprised external exposure to seawater (immersed, splash zone and atmospheric), and internally, seawater with a low hydrochlorite dosing (4%), the coating has not shown any tendency to undercut, and only minor mechanical damage was needed to be repaired.

Left: [The pipes as returned after 21 years' service.](#)

Middle: [Flange area illustrating no under-cutting.](#)

Right: [Pipes in coating – almost complete.](#)

- Flash blast the existing coating. Grit blast damaged flange areas to ISO 8501-1, cleanliness standard SA 2½ with minimum surface profile of 50µm.
- Apply Corroglass 600 Series to a min.dft of 1.5mm.
- Thickness check and spark test to 19Kv Hv-AC.
