Case study: Corrocoat 'E' series for a venturi

Power Generation Industry, UK.

August 2004.

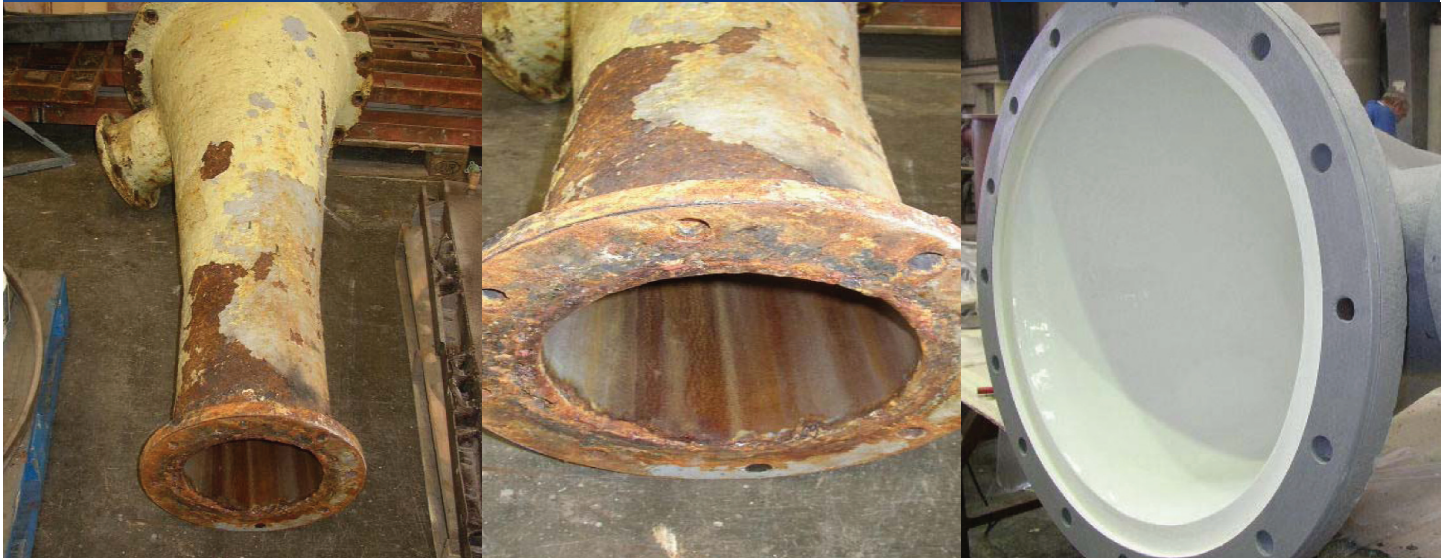
Refurbish and protect a venturi from a sea-water, condensate water system. The component illustrated cavitation and undercutting damage, with severe corrosion around the flange area.

Left: [The venturi on arrival in our Leeds works.](#)

Middle: [Severe undercutting & cavitation damage in the flange area.](#)

Right: [Completed repair and refurbishment. Awaiting packing and despatch to customer.](#)

- Grit blasted internally to ISO 8501-1 cleanliness standard SA 2½.
- Grit blasted externally to ISO 8501-1 cleanliness standard SA 2.
- Applied internally Corrocoat EA / EB to achieve a minimum dft of 2.0mm followed by a top coat of Fluiglide E.
- Applied externally 2 coats of Plasmet ZF followed by a cosmetic top coat.
