## Case study: Treatment for MCW Pump Impeller

Repair and coat pump impeller experiencing erosion corrosion.

Waste Water Treatment plant, UK.

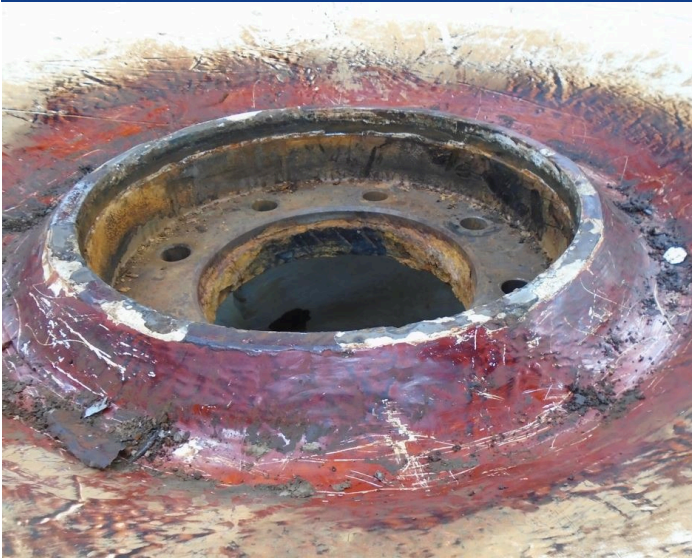
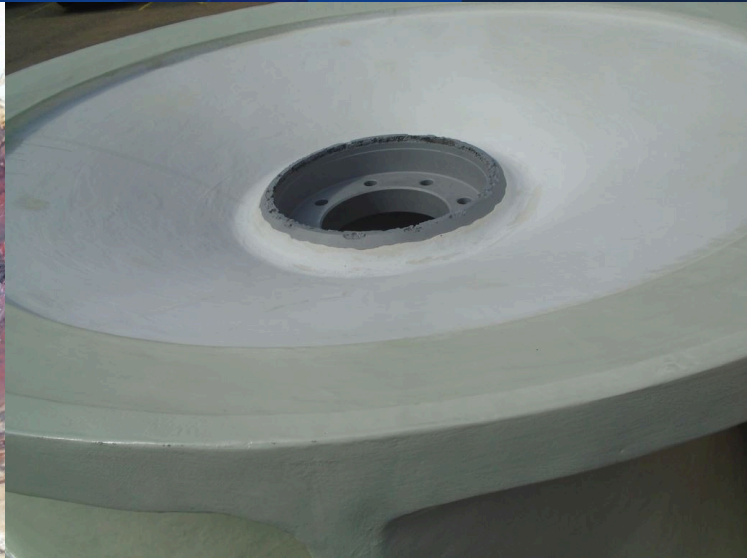
Repair and coat damaged areas of main cooling water pump impeller, which experienced erosion corrosion as a result of its normal every day use.

- Grit blast to ISO 8501-1 SA 2 $\frac{1}{2}$ .
- Corroglass 600 series hand applied, with relative humidity <85% and steel temperature 30oC or greater than moisture dew point, to achieve a minimum of 1500 microns DFT.

Corroglass 600 series was selected due to its excellent performance properties in immersed environments. Due to the glassflake components in the coating, it also has superb resistance to solvents, acids and de-mineralised water and great flexibility undercutting resistance - which is ideal for this particular impeller as it operates in an environment amongst cool, clean water.
