## Case study: Treatment for MCW Pump Impeller

Repair and coat pump impeller experiencing erosion corrosion.

Waste Water Treatment plant, UK.

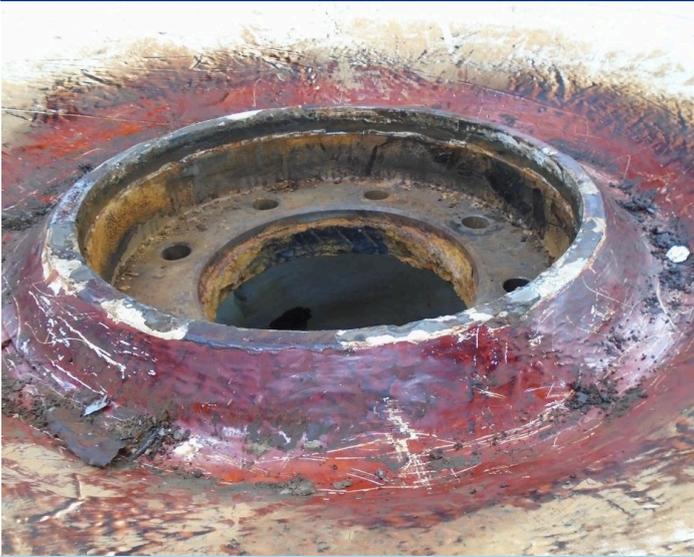
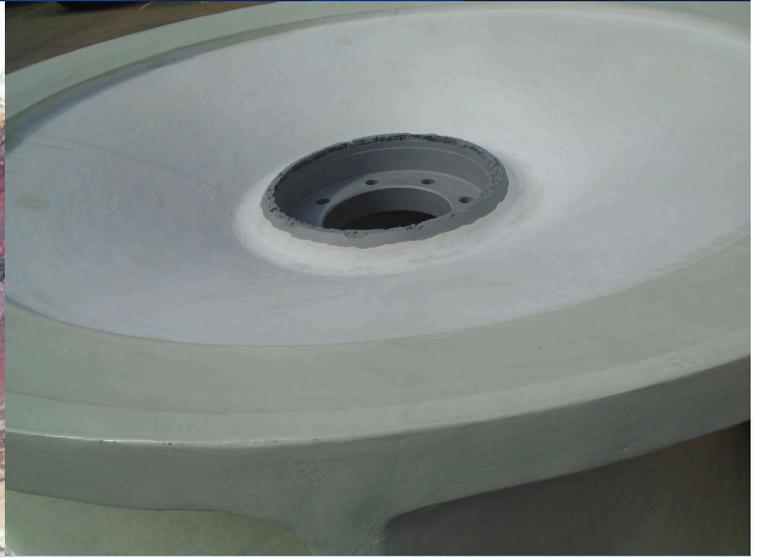
Repair and coat damaged areas of main cooling water pump impeller, which experienced erosion corrosion as a result of its normal every day use.

- Grit blast to ISO 8501-1 Sa 2½.
- Corroglass 600 series hand applied, with relative humidity <85% and steel temperature 30°C or greater than moisture dew point, to achieve a minimum of 1500 microns DFT.

*\* For corrosion protection, thickness is normally 750 microns DFT average. For areas with increased wear, thickness is increased to 1500 microns\**
