Case study: **Refurbishment and Corrosion Protection of a Cast Iron Condensate Pump Casing**

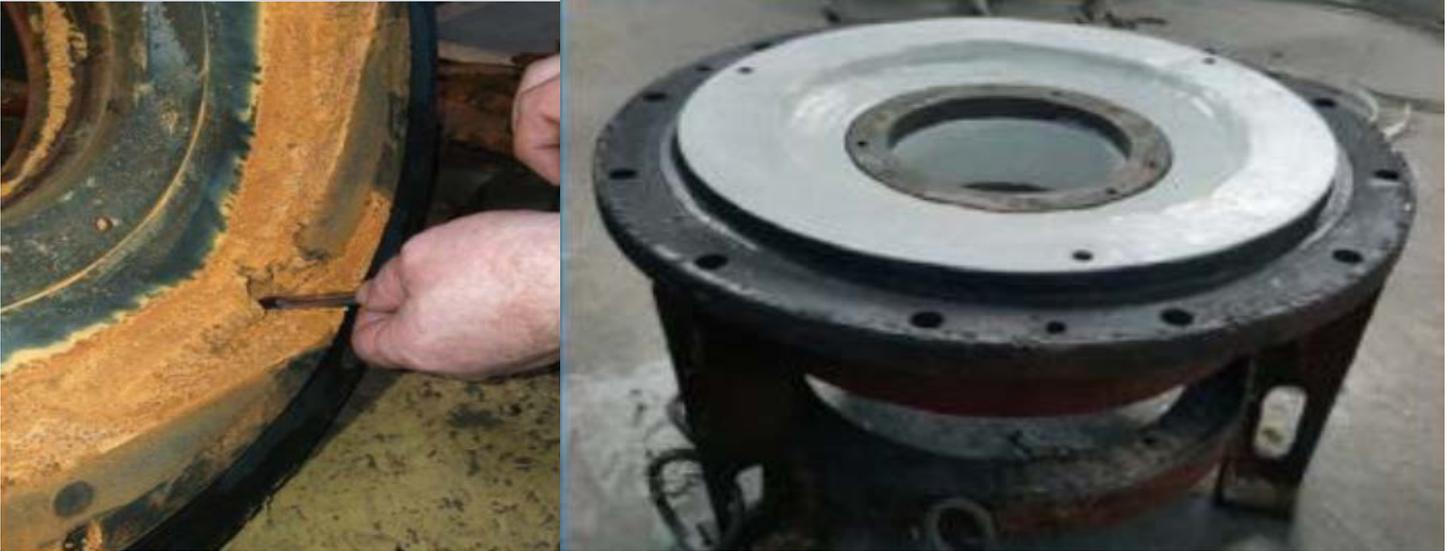
Corrocoat's Belarusian partner (Corrocoat AKZ) were recently commissioned to complete the refurbishment and corrosion protection of a cast iron condensate pump casing at a power station. The pump had been in operation for circa 10 years; pumping water at a temperature of 20° - 60°C, with thermal spikes up to 70°C. On inspection, it was found that the pump casing's internal surface had suffered from cavitation and erosion wear. The depth of corrosion pits was in the range of 10-15mm and the whole casing surface needed to be restored to original condition.

The client required a coating with excellent erosion and cavitation resistance and AKZ proposed the following, which was accepted. The internal surface of the pump casing was abrasive cleaned to ISO 8501-1 Sa2 1/2, after which Corrocoat EA was applied as a filler in the deep pockets of the eroded areas. This was followed by a top coat of Corrocoat EB at a minimum DFT of 2000µm.

As a result of the refurbishment and relining, the pump casing was restored to the required thickness and the applied coating system will provide resistance to the effect of cavitation for a long period of time. The client was extremely pleased with the outcome of the work, and with the savings achieved when compared to the cost of replacement.
