Repair and Strengthening for Pre-stressed Concrete Pipe

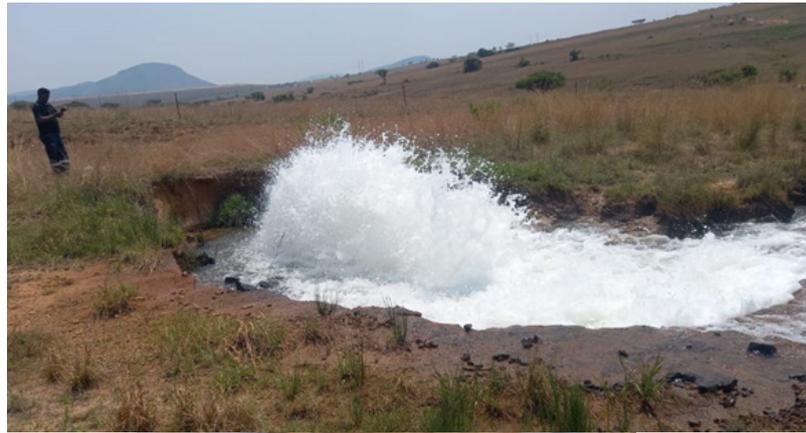
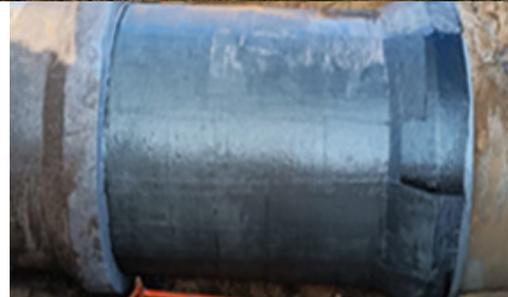
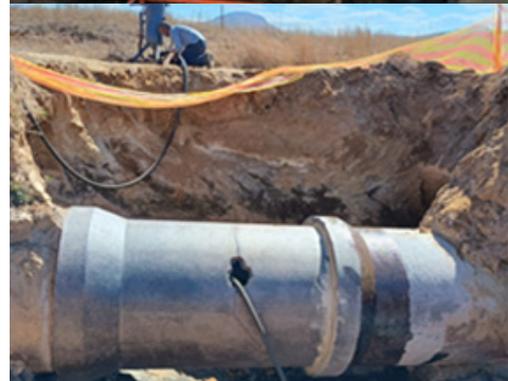
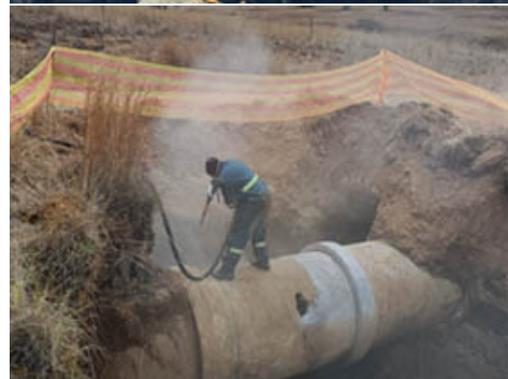
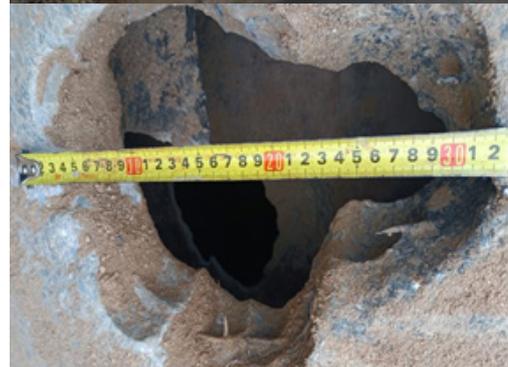
The pipe failure, characterized by a 30cm x 20cm hole and a 2mm wide crack around the entire circumference, necessitated the shutdown of the entire line until repairs could be made. The client sought assistance from Corrocoat South Africa – Johannesburg for a comprehensive solution.

Spanning over 6 days, the critical project involved external excavation and traversing 200m within the pipeline for internal surface preparation, coating, and reinforcement. The team initially blast-cleaned the internal and external surfaces of the concrete pipe. Specialist concrete primers were then applied to reinforce and bond with the immediate concrete surface layer. The holes were filled with Corrocoat Corrofill E, and Corrocoat Zip E was applied to the pipe internals, while Polyglass 100 was applied externally. The internal and external integrity of the pipe was further reinforced using a carbon fibre repair system.

Design calculations were performed for pipe burst resistance, focusing on fibre orientation in the hoop direction for burst resistance. Additional calculations and layers of woven roving carbon fibre were employed for the holed area, while separate calculations for unidirectional carbon reinforcement over the crack were carried out to prevent pipe deflection. The repair not only saved time but also capital compared to replacing the entire spigot with a new, unprotected fabrication. The reinforcement carried out by the team ensured the prevention of future failures at this critical pipeline juncture.
