Case Study: 013

Corroglass 200 & Fluiglide Used to Refurbish Six High Speed Ferry Water Jet Pumps

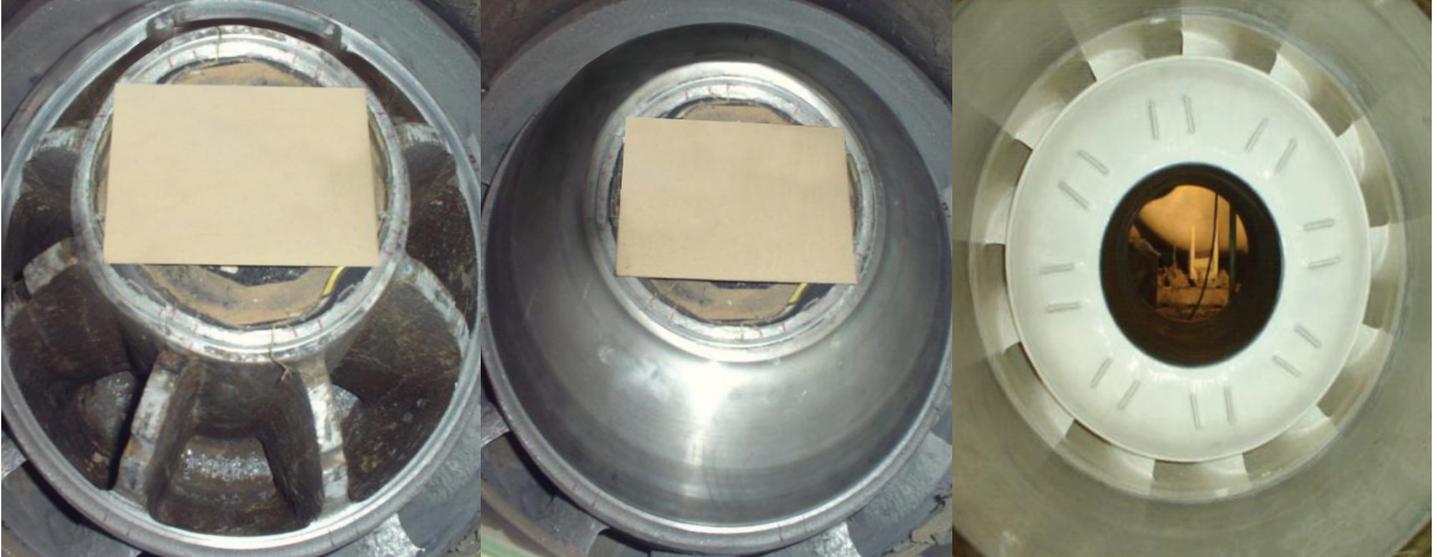
Photographs

Left: The damaged pump dome
Middle: A new dome fitted
Right: The pump after Repair & coating

The work involved: fabricating replacement pump dome covers, rebuilding the guide vanes, grit blasting the pump bodies to standard Sa 2.5, then applying Corroglass 200 and finally a coating of Fluiglide.
