Case study: XT & VEF for an absorber

High temperature protection in a desulphurisation plant.

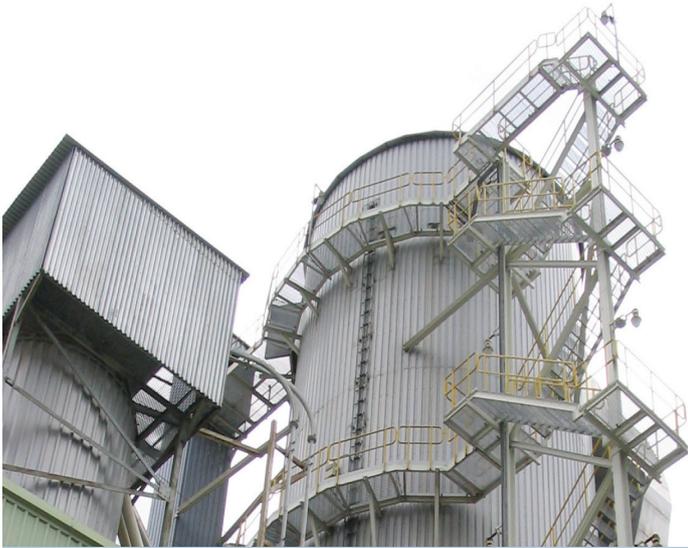
Left: [View of the exterior of the absorber tower – above](#)
Right: [View of the exterior of the absorber tower – below](#)
