CORROCOAT

Case study: Brake cylinder repair

Machine, coat and post machine brake cylinder bore to return to correct bore diameter and surface finish.

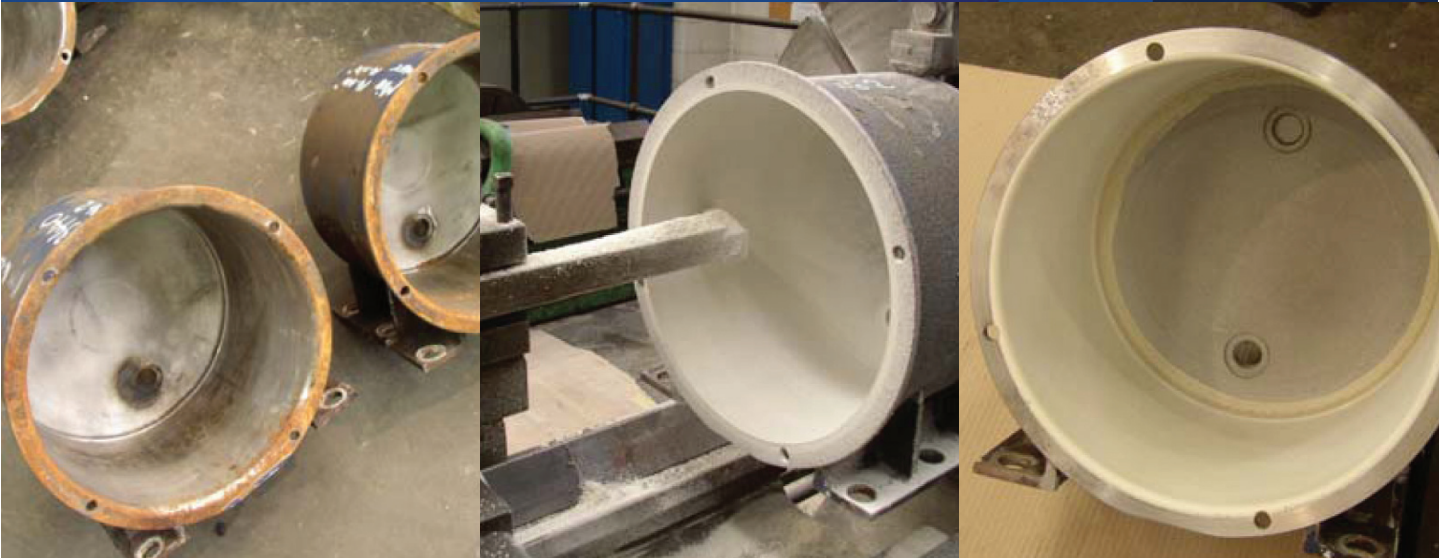
Photographs

Left: [Brake cylinders on arrival in our works.](#)

Middle: [Brake cylinder during post-machining.](#)

Right: [Brake cylinder on completion.](#)

- Pre-machined cylinder bore to $\text{Ø}357.15$
- Grit blast internally to ISO 8501-1 cleanliness standard SA 2½ with a minimum surface area of $50\mu\text{m}$.
- Applied Polyglass VEF (with 5% styrene) by rolling
- Assemble valve
- Post-machined to $\text{Ø}356.1 (+0-0.2)$
- Thickness checked and spark tested at 6.5kv
