CORROCOAT

Case study: VEF for a polisher vessel

Extended life for wet gas scrubbers.

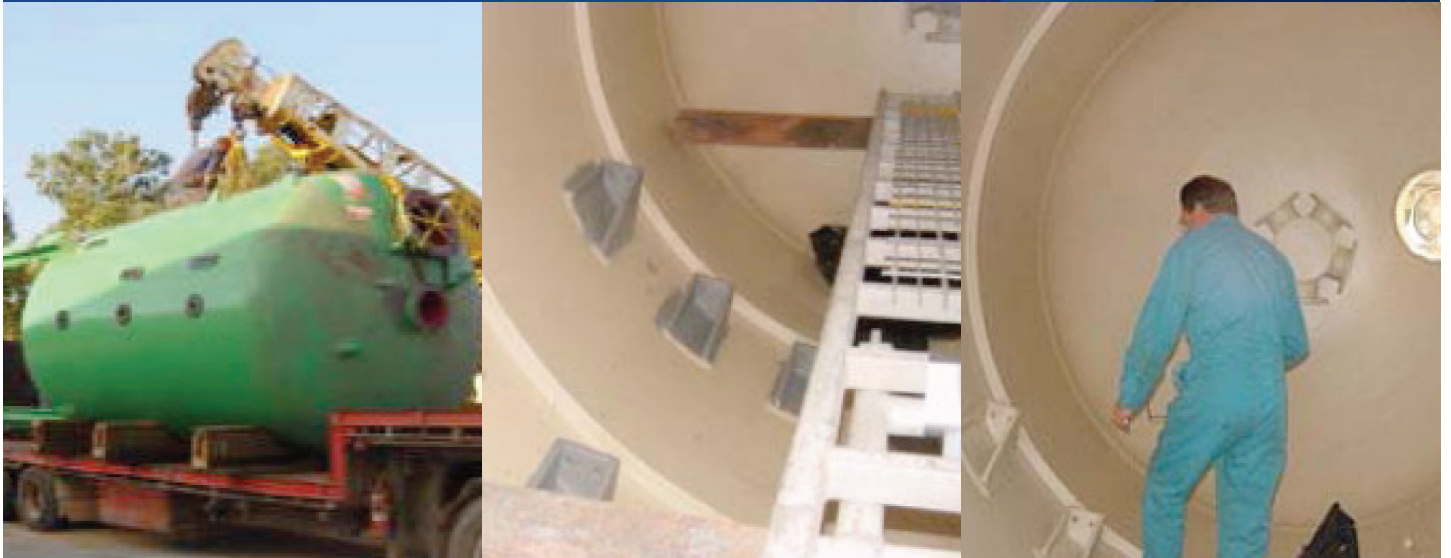
Photographs

Left: [Wet gas scrubber.](#)

Middle: [Internal pit filling.](#)

Right: [Internal spray nozzles.](#)

Grit blasted internally to SA 2½.

Pitfilled with Corrothane XTHA.

Applied Corrothane XT to a minimum dft of 1.5mm.

100% Spark tested and thickness checked.

The scrubber process water contains various chemicals creating a very corrosive cocktail, including salt, ammonia and sulphuric acid at an operating temperature of 101°C with potential short term peaks of 330°C. Over many years, corrosion had occurred resulting in severe pitting and significant loss of the metal substrate. Corrocoat Corrothane XT was spray applied and trowel applied to fill all pits on the internal surface of the scrubber.
