## Case study: Corroglass 600 for fan unit

### Corrosion protection for fan unit.

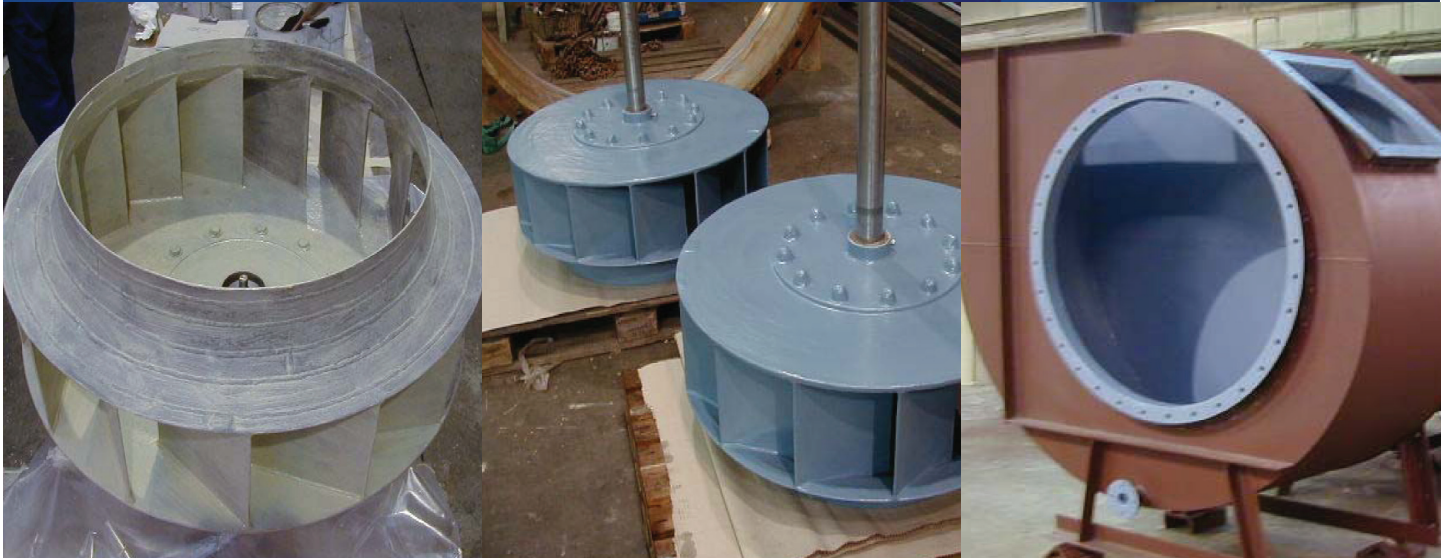
#### Photographs

Left: [Impeller in coating shop after grit blasting and primer coat.](#)

Middle: [The fully completed and inspected impellers.](#)

Right: [Casing completed, awaiting despatch.](#)

- Internal: The impeller was grit blasted to ISO 8501-1, SA 2½ and treated using Corroglass 600 Series materials.
- The casing was grit blasted internally to the same standard, followed by application of Corroglass 600 Series to a minimum dry film thickness of 1mm, carried into the flange rebates and finished flat to ensure optimum performance in use
- External : The area was grit blasted to SA 2 and protected using two coats of Plasmest ZF.

Using Corrocoat's Engineering facilities the impeller was fully balanced to BS6861-pt1.
