Case Study: 008

## Refurbishment of Hydrogen Cooling System

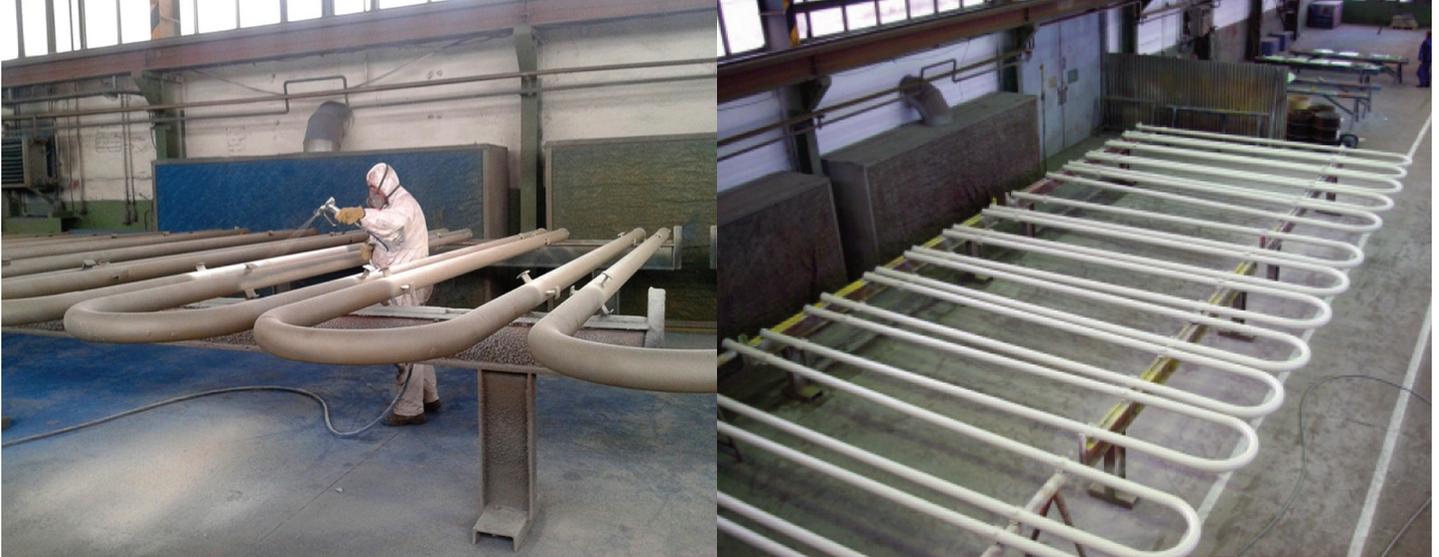
Carrying out the work in its own workshops, the coils were first degreased, then high pressure water jetted, before being blast cleaned to standard Sa 2½ with a sharp-edged surface profile corresponding to Rugotest No. 3, BN9a. The external surfaces, some 1500²m in all, were then coated with Polyglass VE to a dft of 1500 microns.
