# EXTERNAL WRAPPING AND PROTECTIVE COATING WITH PLASMET HTE OF A FAILED ALUMINIUM FLUTE

## Failed Aluminium Cyclone

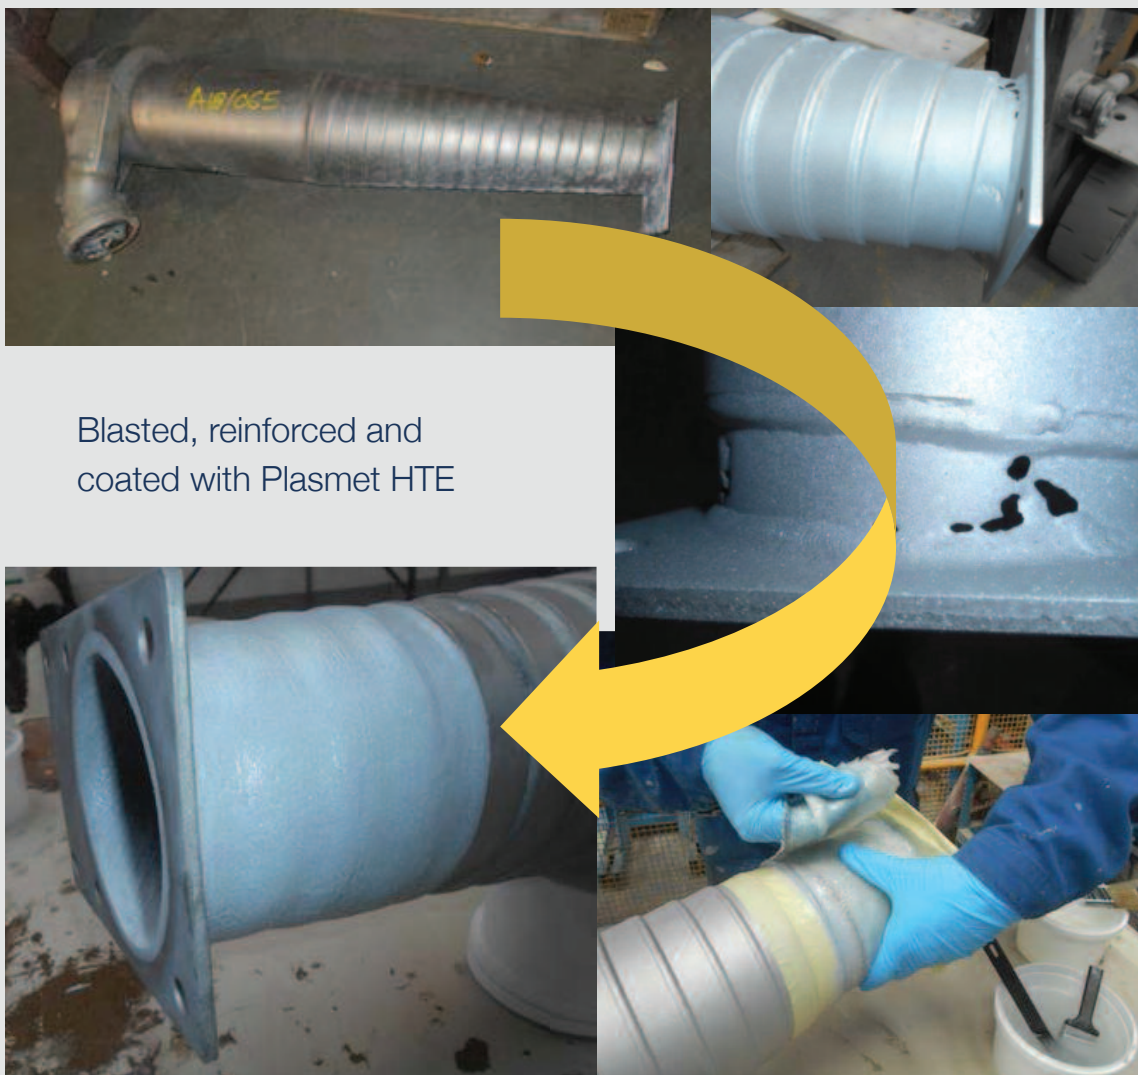
Blasted, reinforced and coated with Plasmert HTE

A cyclone flute from a paper mill was found to be holed after operating in a highly aggressive abrasive environment.

The area to be repaired was blasted to SA2½ and externally wrapped with 300gsm matting wetted out with Corrocoat Laminating Resin 600. Thereafter multiple coats of Plasmert HTE were applied to the external and internal surfaces to a required dry film thickness of 2000µm.
