A message from our CEO & Technical Director

Also in this issue...

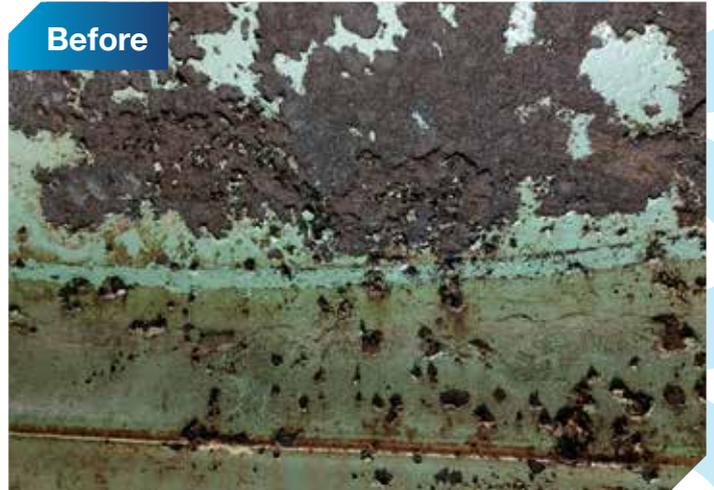
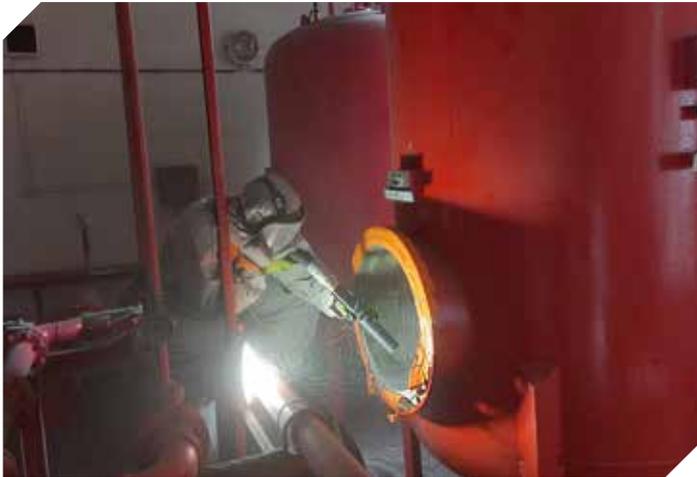
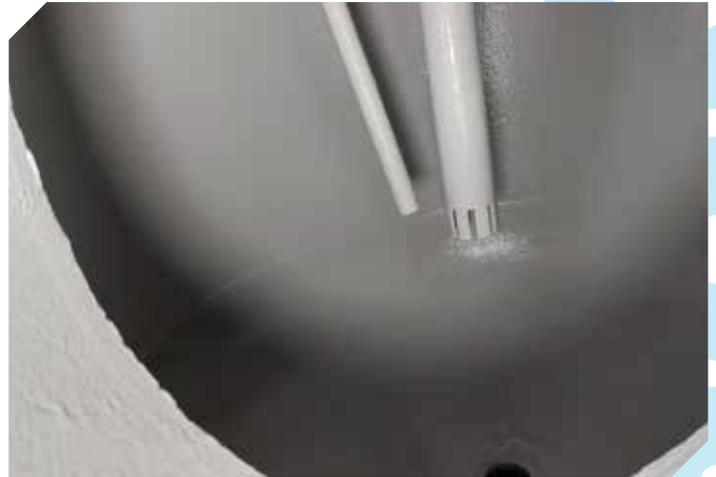
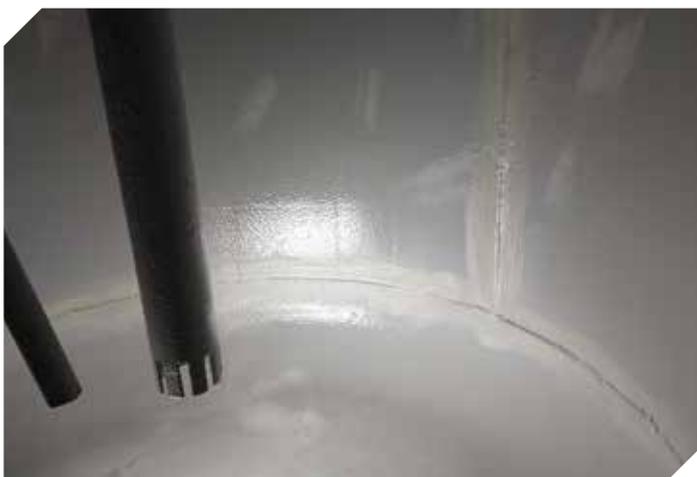
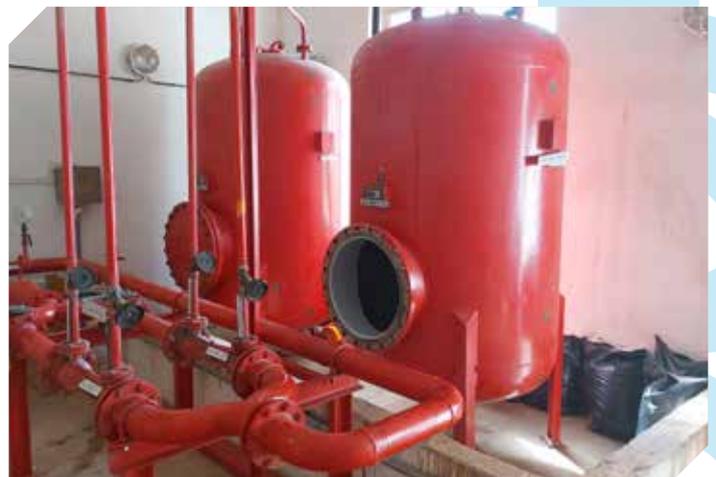
The tanks stored a fire foam concentrate which had caused damage to the existing internal lining resulting in pitting corrosion. The Corrotech team carried out the work in-situ at the Nuclear Power Station and began by removing all of the existing deposits & paint before decontaminating the surface from soluble salts.

Following abrasive blasting, the team discovered a number of sharp edges and poor quality welds, which needed to be mechanically repaired ahead of the coating system being applied.

The coating selected for this job was Corrocoat Zip E, an epoxy glassflake coating offering durable protection in aggressive service conditions – ideal for the long term protection of the internal substrates of these fire foam tanks.

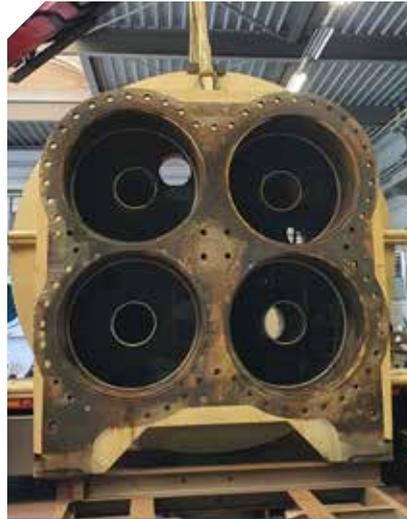
Following 8 years in service, the epoxy coating in the internal cooling water area became detached, causing a leakage in the cooling water area of the air section. Unbeknownst to the team, the housing unit weighed an enormous 13 ton and upon arrival to the workshop presented a logistical challenge getting the unit offloaded and ready to begin the repair work. The overhead crane onsite was only capable of lifting 6 ton, so the team arranged for a mobile crane to move the housing unit. With a tight schedule of just two weeks given to complete the work, the coating team didn't disappoint, working around the clock to ensure that the job was completed to the client's satisfaction.

Cooling water area before protective coating

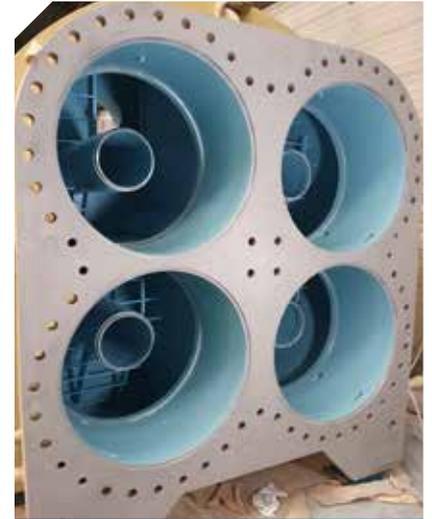
Cooling water area following protective coating

The team sandblasted the housing internal and external before applying the Corroglass 600 series internally, with the externals being coated with Plasmest ZF and a top coat of AP1.

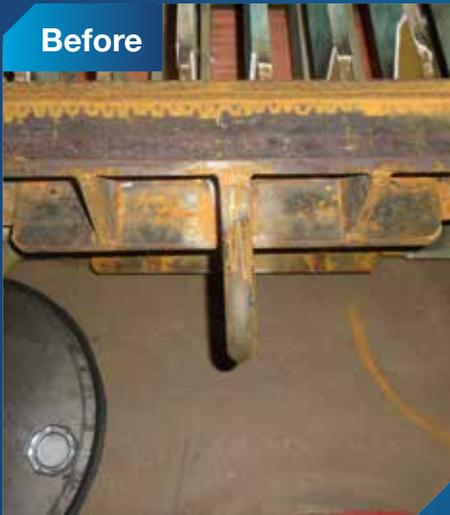
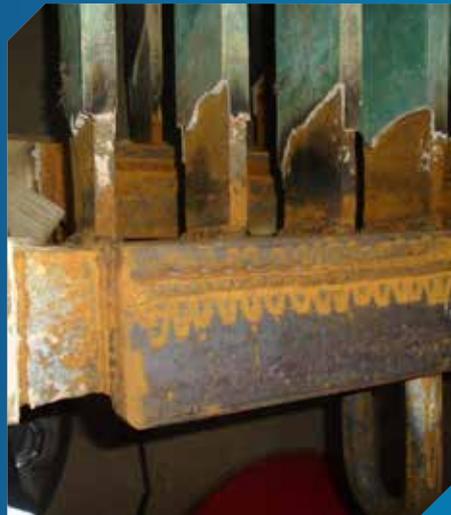
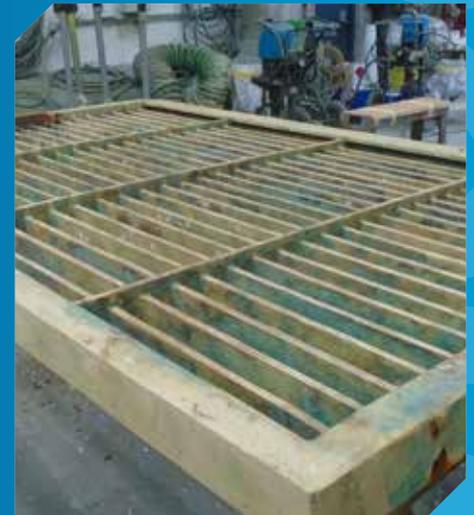
Before

A leading energy company in the UK recently required refurbishment of two jetty intake screens. The screens had been in service for approximately 12 years and had suffered mechanical damage. The client had also welded on new lifting points which required protection and coating repair. They had previously needed to take out the screens and manually remove the marine growth which restricted the water flow into the cooling water system, reducing the efficiency of the condenser, which could impact the power generated from the station.

Upon arrival to the workshop the screens were flash blasted to reveal the true extent of the damage and in turn the repair required.

Surface preparation then followed on the carbon steel substrate and on the new lifting lug area. Following cleaning to prepare the surface ahead of coating, Corroglass 600 Series was then used to achieve a minimum DFT of 900 microns, with the appropriate thickness and spark tests being completed following adequate cure.

Biofoul was applied via airless spray, as a topcoat to achieve a minimum DFT of 300 microns. Biofoul was selected as it has excellent long term fouling resistance and will resist flow velocities of up to 25m/s. The coating contains metallic copper and no fillers which are classified as toxic, such as TBT and some copper salt materials.

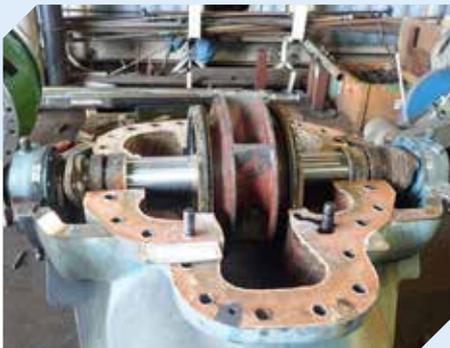
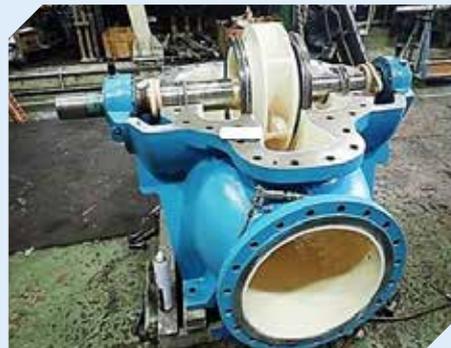
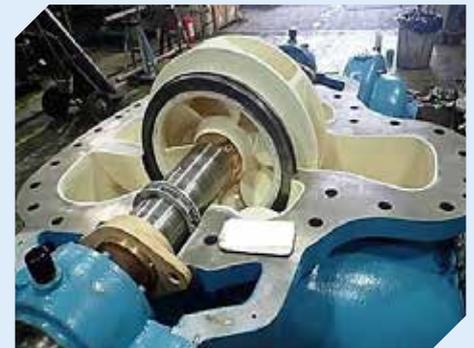
Corrocoat Japan worked with a client in the Chemical Industry to assist them with saving energy by targeting the double suction pump of a cooling tower pump, which had been in service since 1986. The pump had long operating times and relatively large power loads and the aim of the project was to carry out maintenance to improve the overall energy efficiency.

The pump was disassembled and any worn or defective parts were repaired or replaced. The internals were then coated with Fluiglide and the externals with Corroglass 200.

The team confirmed an impressive energy saving value of 9.2%, which was the equivalent to 35.16 kw/h, significant to 281,280 kWh/year. A fantastic result leading to a reduction in operating costs and the large power consumption for the client, alongside the necessity of recovering the original pump efficiency to improve the overall cooling performance system.

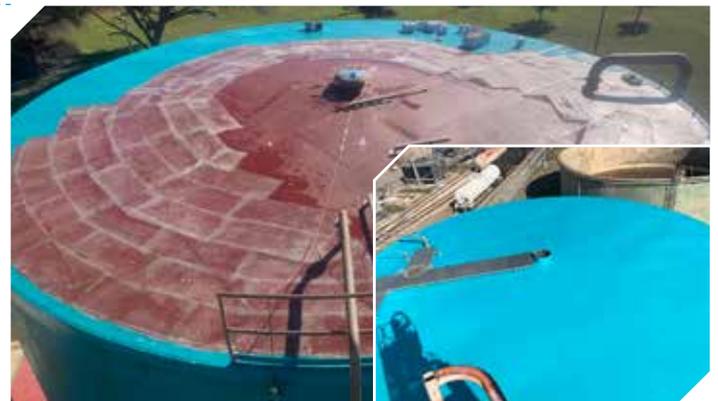
Three months after completion, the client found that the contractor had blasted hundreds of holes in the roof of the tank and had coated over them. This allowed rainwater to contaminate the contents of the tank. When confronted, the contractor advised that their scope of work did not include filling holes. In desperate need of a solution, the client turned to Corrocoat USA.

The team in the US vapour blasted the existing coating to achieve a commercial blast consistent with SSPC SP6.

The surface was then primed with Plasmert ZF (red) ahead of using Epoxy Laminating Resin and quadriaxial fiberglass mat to laminate a composite fiberglass layer across the entire tank roof. The team then chose a suitable polyurethane topcoat to offer UV protection in a colour that matched the remainder of the tank. The client was extremely impressed with the final result and the quality assurance and will continue to work with Corrocoat US on future projects.

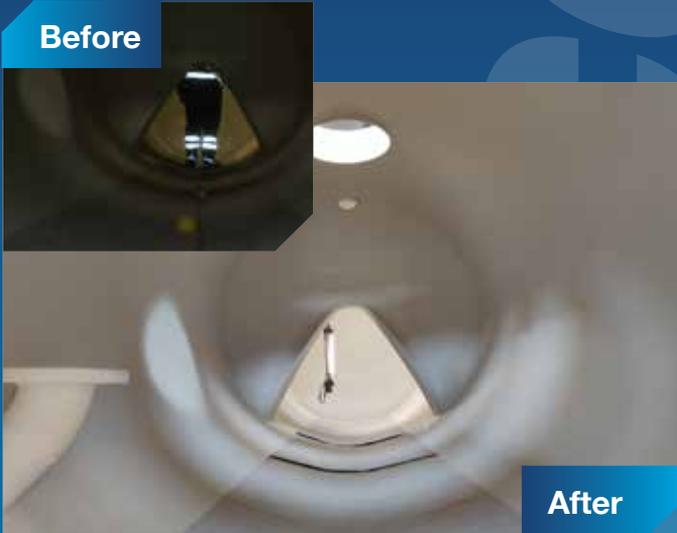
Before

The tank was 7.5m long with a diameter of 1.91m. Access was provided through two off 600mm tank top manways and another at the bottom of the rear dish. The tank would be collecting acidic liquids, with the possibility of weak solvents, all at ambient temperatures. With this in mind, Polyglass VEF was the coating system selected for the job. Polyglass VEF is specifically designed to offer the corrosion in aggressive chemical environments and has a proven track record with road tankers

The first coat of Polyglass VEF was applied by airless spray to a minimum WFT (Wet Film Thickness) of 600 microns. As part of a comprehensive corrosion protection coating system, fibreglass woven matting was applied to the interface areas of the tank and the bottom 1/3rd of the shell below the manway access points, i.e. baffle joints and manway neck joints. These reinforced layers improved the tensile properties of the coating and cracking resistance due to movement.

Following a second coat of Polyglass VEF to a specified minimum DFT of 1200 microns, thickness checks, spark testing and a 100% visual inspection was completed. A final topcoat of Polyglass VE Veilcoat was then applied. On completion of the application, the coating was post cured at 60–80°C for 8 hours to ensure the full cure offered resistance required against the waste streams being collected.

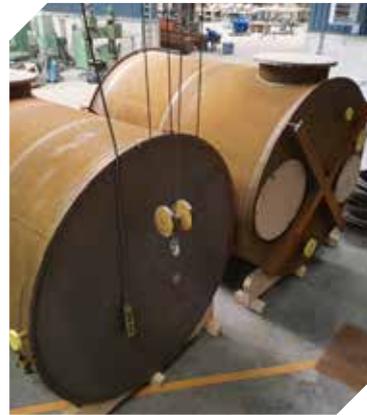
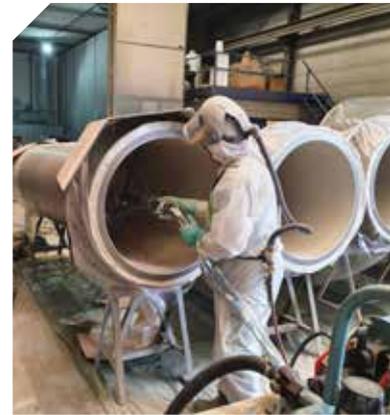
The equipment was destined for a large salt plant in Europe, where the pipes would be used to transport brine and the tanks would be used to store cooling water. The internals of the pipe pieces and tanks were coated with Polyglass VEF at a minimum thickness of 1200µm and a general paint system at a thickness of 340-400µm was used for the externals.

Due to the large size of the pipe pieces and tanks, overhead cranes, a forklift truck and a lorry were used to transport the equipment throughout the workshop for the work to be carried out, whilst a pipe sprayer was used to apply the coating on the inside of pipes and ensure an even layer of coating.
