# CORROCOAT NEWS

AUTUMN '90

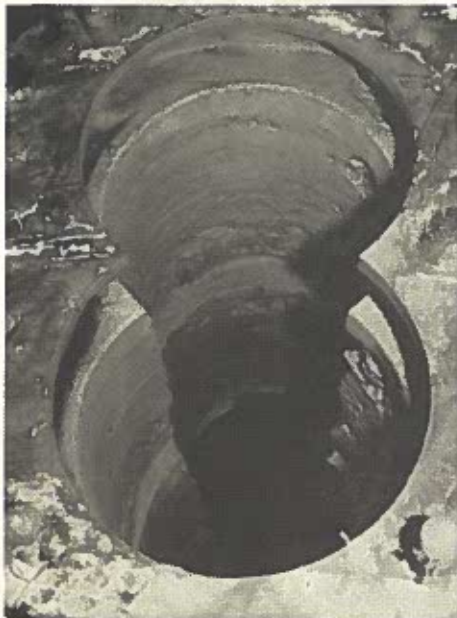
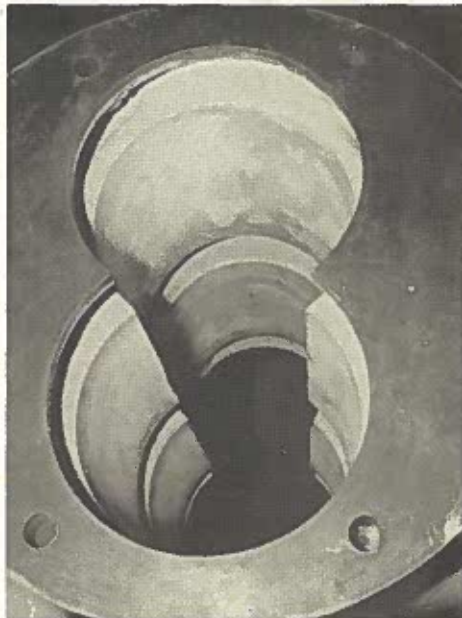
When the MS Petrol Bulk Rover owned by Naess Shipping was in drydock recently, it was discovered that the bores of one of the scroll pumps used to take on and discharge cargo had been severely damaged by erosion/corrosion. This damage had reached a point where efficiency was greatly reduced, with potentially adverse effects on discharge and load times.

Within the limited period determined by the length of the drydocking, Corrocoat personnel collected the scroll pump from site, pre-machined the unit to allow for the necessary coating thickness, then masked and gritblasted the bores. The unit was coated, using our own Corroglass 600 series, and post-machined back to the required dimensions to suit the scrolls.

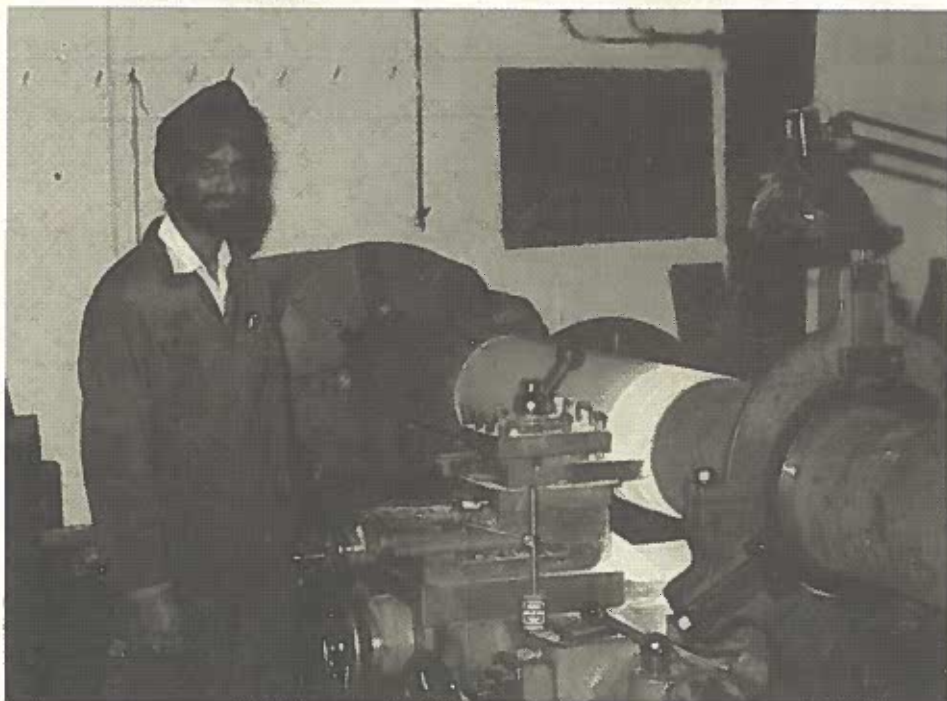
Mobil requested that Corrocoat examine the possibility of creating a one metre 'collar' of protective coating around the outer surface of the riser pipes, achieving an area which could move freely

dependent upon temperature fluctuation, yet retain high levels of corrosion protection.

Corrocoat engineers were confident that our own flake glass filled coatings could be utilised for this duty, and would retain stability after machining. However, the task was further complicated by the nitrile seal on the stuffing box, which demanded a close tolerance diameter and smooth surface finish in order to continue to perform effectively.

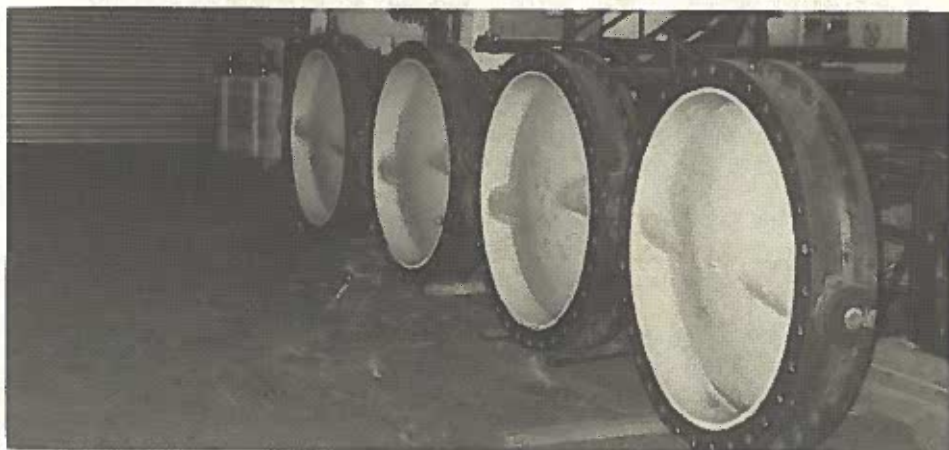
We were extremely interested to see a collection of 48 inch nominal bore butterfly valves from Longannet Power Station, which arrived recently for refurbishment at our Leeds headquarters.

In comparison with the untreated valves, these two units were in an excellent state of repair. The condition of the coating was such that we were able to offer a greatly reduced cost for carrying out mechanical overhaul only, to accept the new 'eyeball' seal design, which we developed and patented specifically for this type of valve. Yet another example of the extreme longevity of our materials!

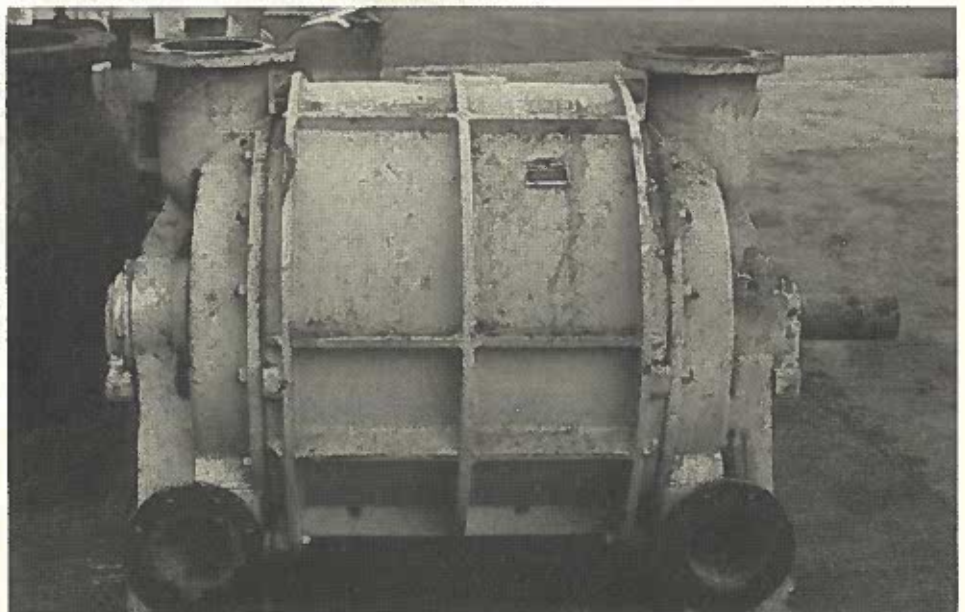
The pumps in question operate in a particularly aggressive environment, extracting water with a chemical taint, which had resulted in severe corrosion/erosion damage to the two units - in particular to the end plates and cones. Previous repair methods had proved unsuccessful, and maintenance engineers at Davidsons were seeking a more reliable and permanent solution.

The pumps were sent to our Leeds base for strip and evaluation. Despite the extensive damage, our team of specialists were able to use coating techniques to effect a full engineering repair, involving

pre- and post-machining in close tolerance areas.

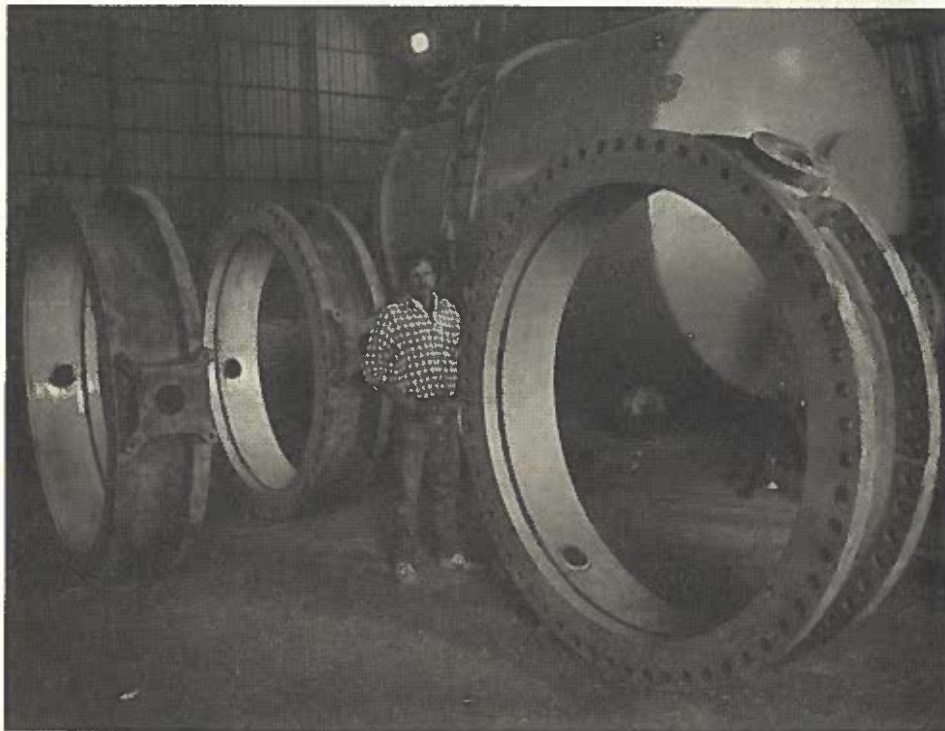
A recent contract for the refurbishment of three 72" diameter nominal bore Triton BF valves gave Metalcoat a good opportunity to demonstrate the advantages of professional engineering repairs over replacement.

The valves, operational within the cooling water system of a local power station, posed a number of challenges for Metalcoat. On-site repairs were impossible, as the units were located in a tidal zone, with the lower two feet of the valve remaining constantly underwater. The resultant severe corrosion damage to the cast iron bodies meant that the discs would not seat properly.

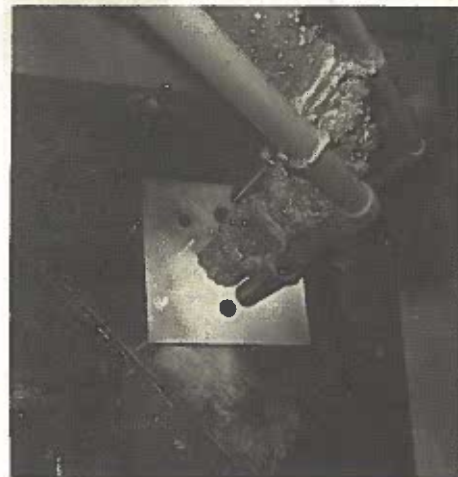
Over the years, this combination of turbulence and chemical attack from the chlorine and sulphuric acid had resulted in damage to the concrete walls of the flash mixer. In addition, the mixing chamber plinth - manufactured from concrete with a glass plate on the top surface - had suffered severe damage. In some places, concrete loss was as much as 100mm, exposing the reinforcing bars.

The detailed repair task carried out by Corrocoat UK involved removal of the existing gunnite screed, and treatment of the entire tank using Polyglass. The badly damaged mixing chamber plinth was rebuilt to original specifications and coated with Polyglass. The repair was completed in May of 1987, and the flash mixer returned to use.

In February of this year, the unit was drained down to allow a full inspection of the coating. Careful examination revealed no failure or deterioration, even in the area which had previously suffered extensive damage. The flash mixer was returned immediately to service.

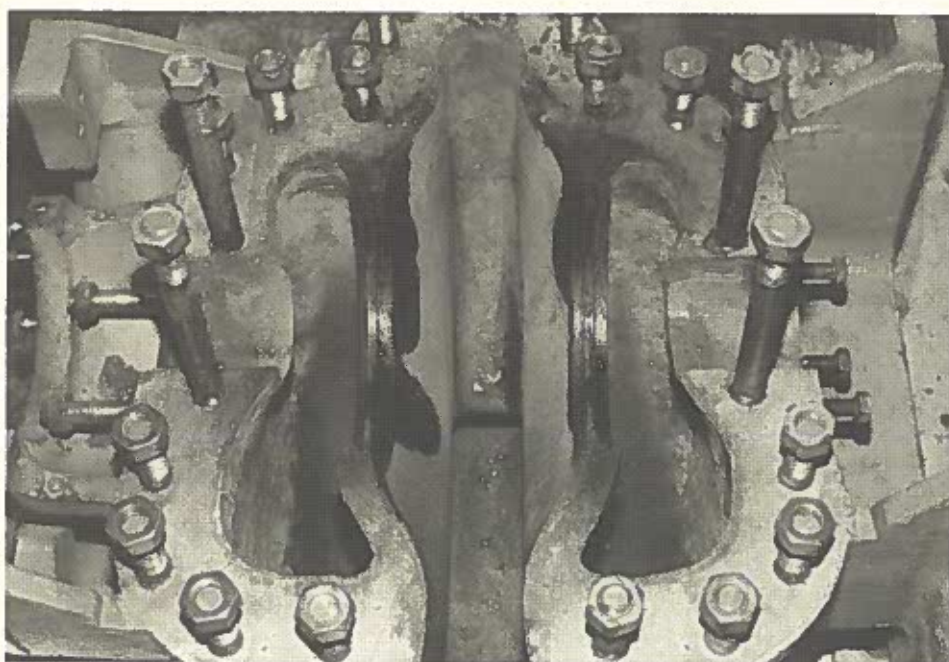
*No. 1 pump, bottom casing with rotating element removed*

was left in situ, untreated, for operational reasons.
