Case study: Coating over 300 new Pipespools

Pipespools would be subject to service in seawater in Angola.

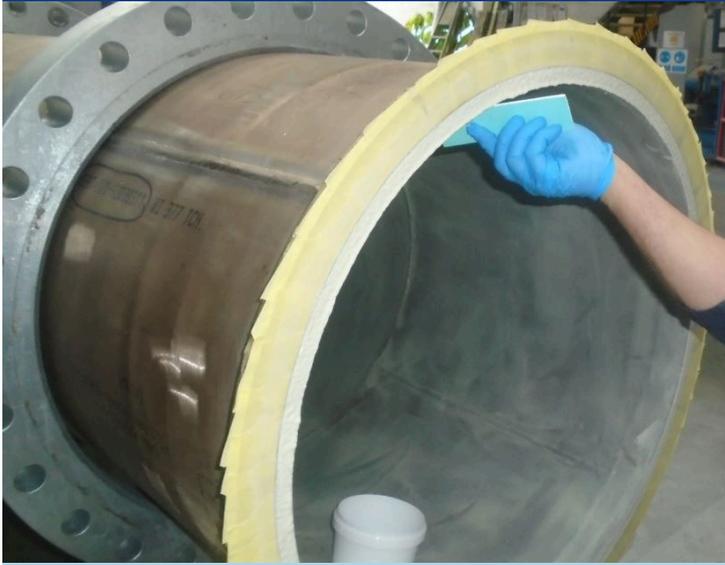
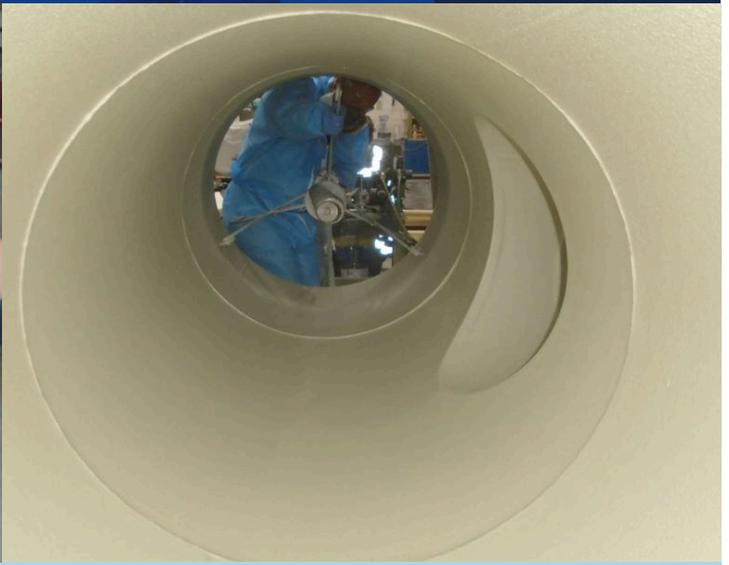
Client required over 300 brand new pipes to be coated to protect from seawater damage, before being shipped overseas for service.

- Internal grit blast to ISO 8501-1 Sa 2½.
- Complete blow down, sweep and vacuum clean.
- Polyglass applied with a pipe sprayer to a minimum DFT of 1250 microns.
- Thickness testing and spark testing following adequate cure at 17kv

- Surface protection removed, edges dressed and welds prepared to comply with Corrocoat spec 6/40, weld finish.
- Grit blast to ISO 8501-1 Sa2 ½ .
- 2 coats of Plasmjet ZF and a single coat of Corrothane AP1.

To prevent corrosion of the under gasket, we recommended that the flange faces be rebated and coated to prevent under gasket corrosion.
