REFURBISHMENT, AND PROTECTION OF RAW WATER PUMP

CASE STUDY

250/400 Centrifugal Pump

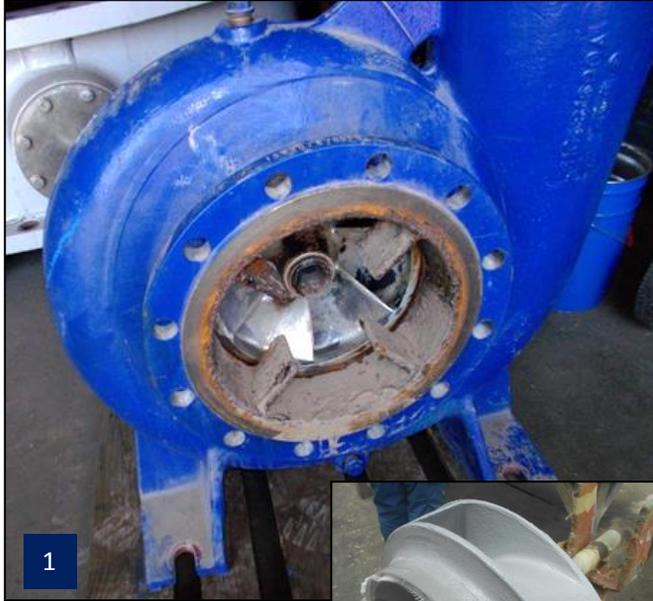
1

1: Pump on arrival. 2: Impeller during the coating process. 3: Completed pump casing reassembled after coating, before impeller re-fitted.

The pump was stripped down and both the casing and impeller were abrasive blasted to the required cleanliness standards, before the casing was pre-machined to accommodate the coating process.
