## On-line Leakage Stop of CO<sub>2</sub> Pipeline Elbow

Petrochemical Industry Plant, Czech Republic

November 2023

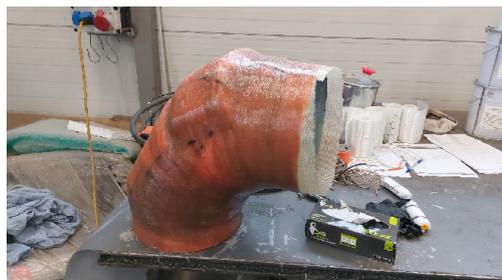
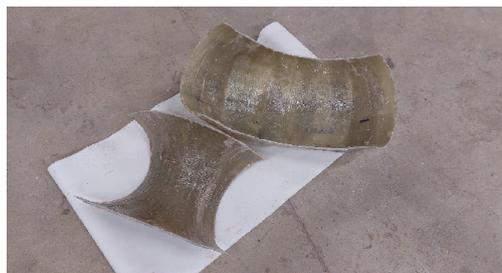
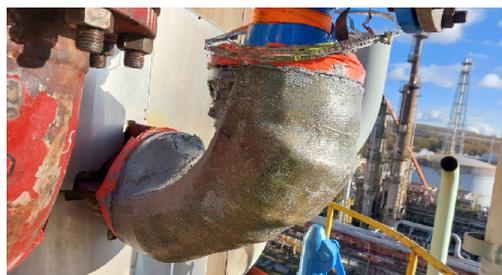
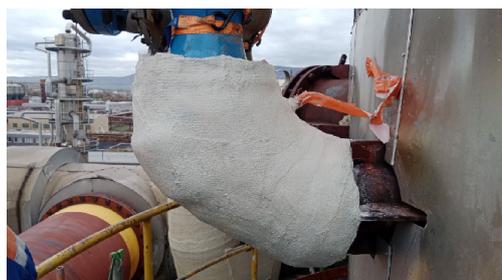
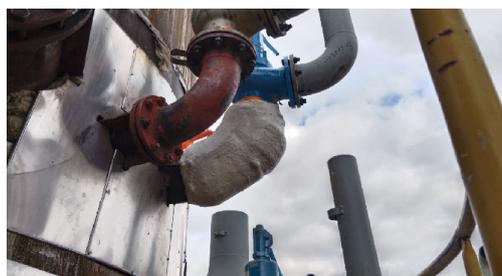
A petrochemical plant in the Czech Republic experienced a CO<sub>2</sub> pipeline elbow leak that had the potential to take a section of the facility offline for several days. The leaking external of a carbon steel pipe elbow had previous coating unsuccessful repairs to stop the leak. Expensive downtime due to offsite repair or full replacement could be avoided with an online repair solution utilizing CORROCOAT products.

Following an inspection, surface preparation of contact area was undertaken onsite whilst work got underway with preparation of a 4 mm thick component (Lamination Resin 600 + Multiaxial Fiber Glass Cloth 600 g/m<sup>2</sup> in the workshop. This was then taken to site for installation once filled with CORROFILLVE onsite. Strength was further bolstered with the lamination wrap over the component and application of POLYGLASS VE HA over the lamination reinforcement.
