Global Reach, Local Pride:

Celebrating the success of
our international partners.

Also in this issue...

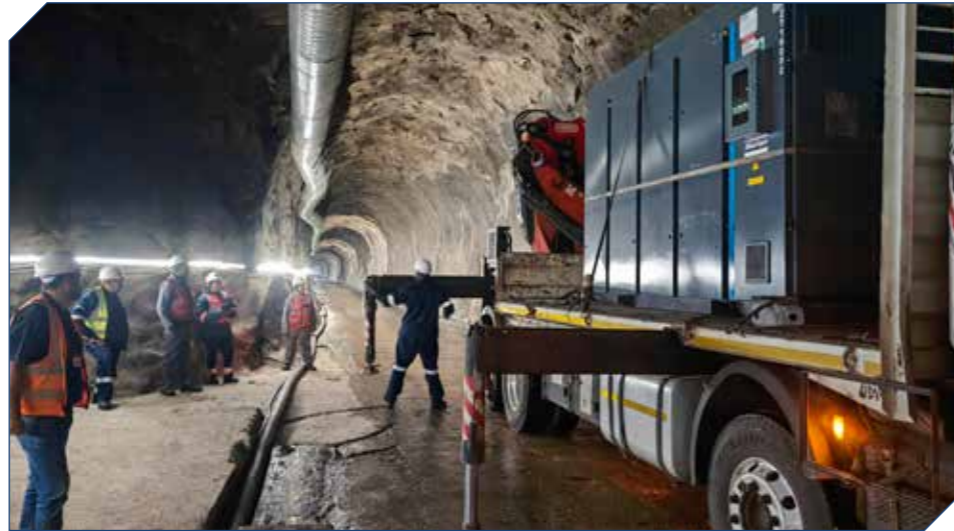
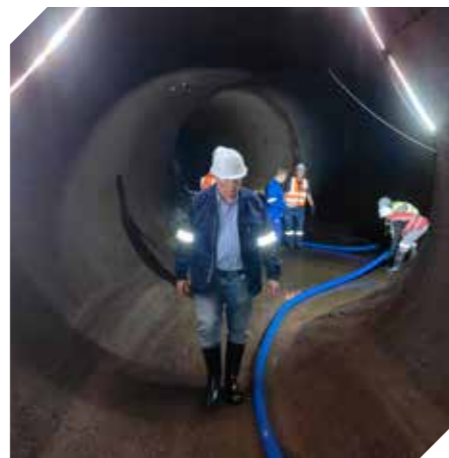
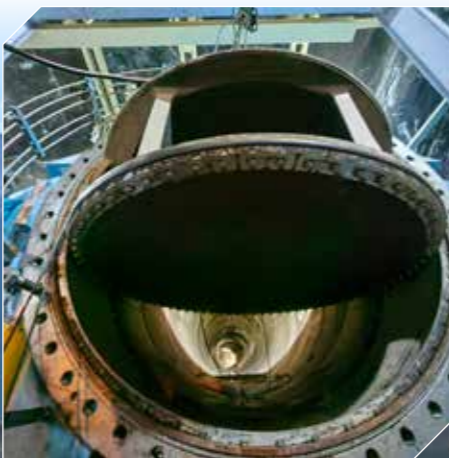
During inspections of the Transfer and Delivery Tunnels between September and November 2019, it was established that the internal corrosion protection lining in all sections of the tunnels (that are steel lined) was wearing off and if left for too long, there was a risk that steel tunnel sections would corrode. The specialists advised that the tunnel could safely be operated for a period of around 5 years (October 2019 to October 2024). Safe operation of the system significantly beyond the 5 years could not be guaranteed.

Corrocoat SA (Pty) Ltd, partnering with LHDA, undertook extensive corrosion protection refurbishment, maintenance and repair works in the steel tunnels, requiring a complete shut-down of the entire Water System as well as at Muela Power Station, to undertake the critical corrosion protection refurbishment work.

- Corrocoat Zip-E glassflake high solids epoxy to 1000 microns in a single coat.
- Circa 20,000m² of steel liners up to (3 and 4m in diameter) to be refurbished over 6 discrete project sites throughout the tunnel system (the furthest site being 2 hours' drive away over the mountains to Katse Dam).

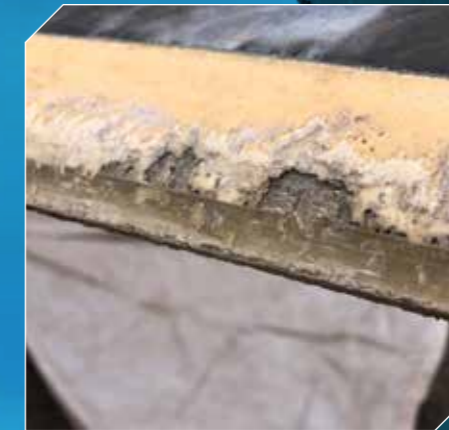
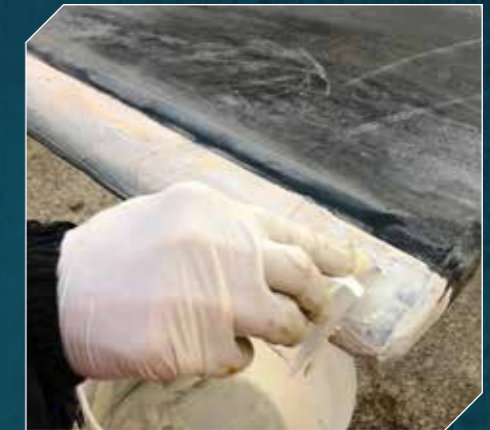
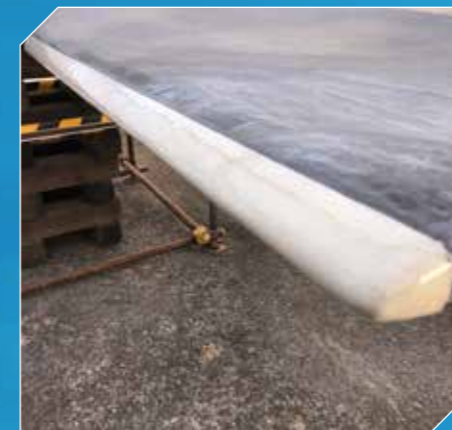
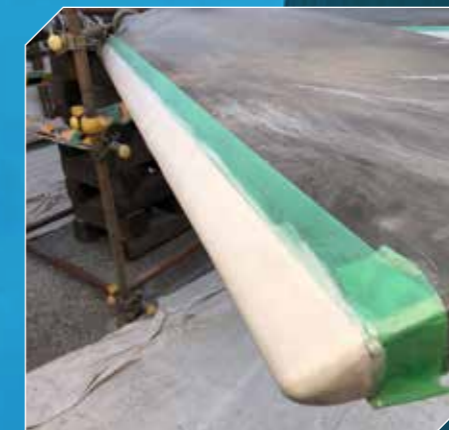
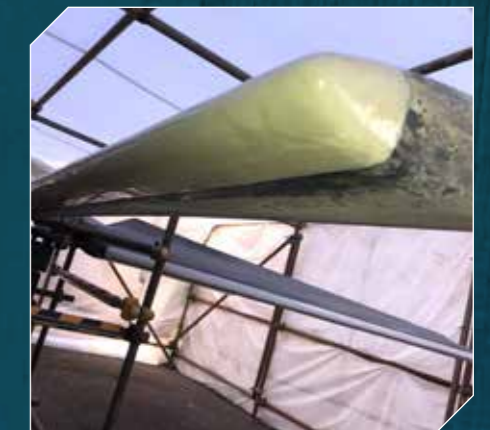
With the front edges of a cooling tower fan showing signs of corrosion, as well as general wear and tear, the facility owners sought Corrocoat Japan's help to restore the fan blades, in order to extend their lifespan.

The team started with a grinder to remove the corroded blade edges, maintaining as close an alignment to the original shape as possible. The blades were then cleaned and degreased using solvents. Glass cloth and Corrocoat 600 Lamination Resin was applied to repair the severely corroded areas and profile adjustment made using sandpaper, to refine it to its original shape. A layer of Corrocoat 600 Series was then applied for additional endurance.

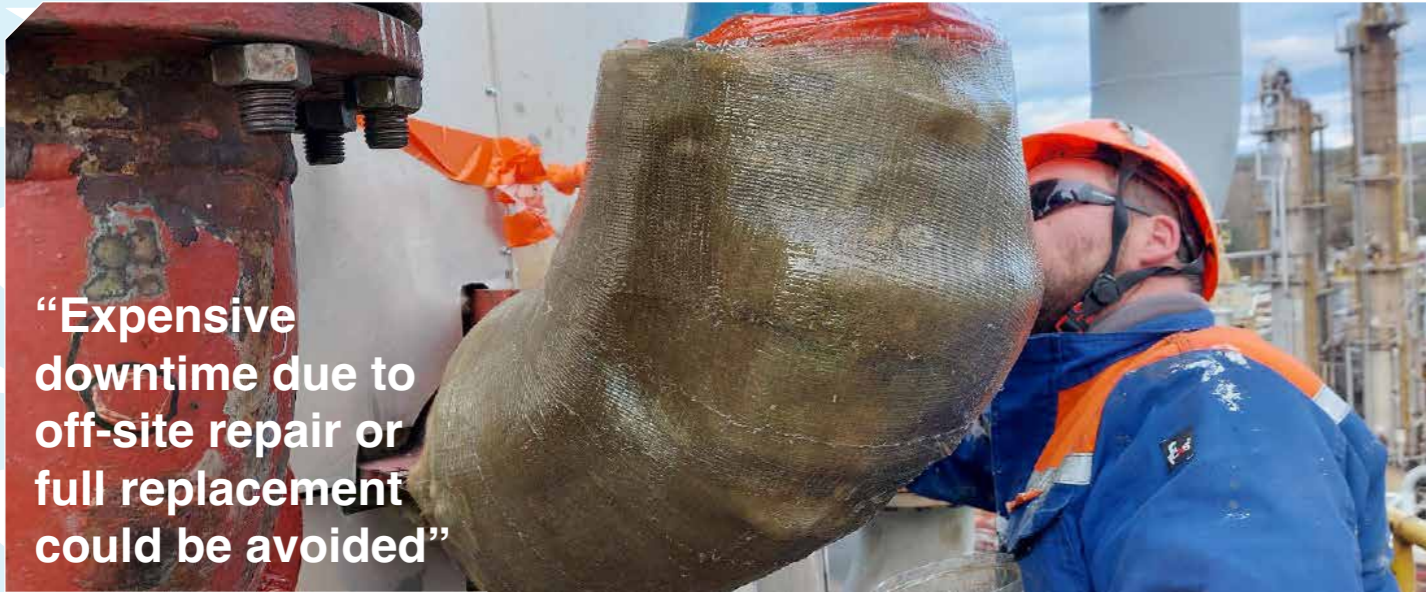
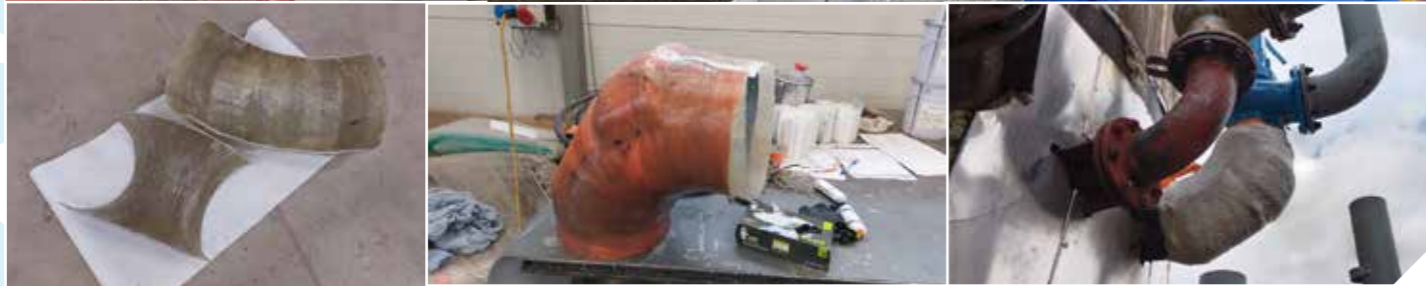
On-line leakage stop of CO₂ pipeline Elbow

A petrochemical plant in the Czech Republic experienced a CO₂ pipeline elbow leak that had the potential to take a section of the facility offline for several days. The leaking externals of a carbon steel pipeline elbow had previous unsuccessful coating repair attempts to stop the leak. Expensive downtime due to off-site repair or full replacement could be avoided with an online repair solution utilising Corrocoat products.

Following an inspection, surface preparation of the elbow was undertaken on-site whilst work got underway with fabrication of a 4 mm thick FRP enclosure, using Corrocoat 600 Lamination Resin and Multiaxial Fibre Glass Cloth 600 g/m² in the workshop.

Once the elbow was prepared and primed with Corrocoat 600 Series, the enclosure was installed around the elbow and filled with Corrofill VE on-site. Strength was further bolstered with an additional layer of 600g/ m² cloth before being coated with Polyglass VEHA.

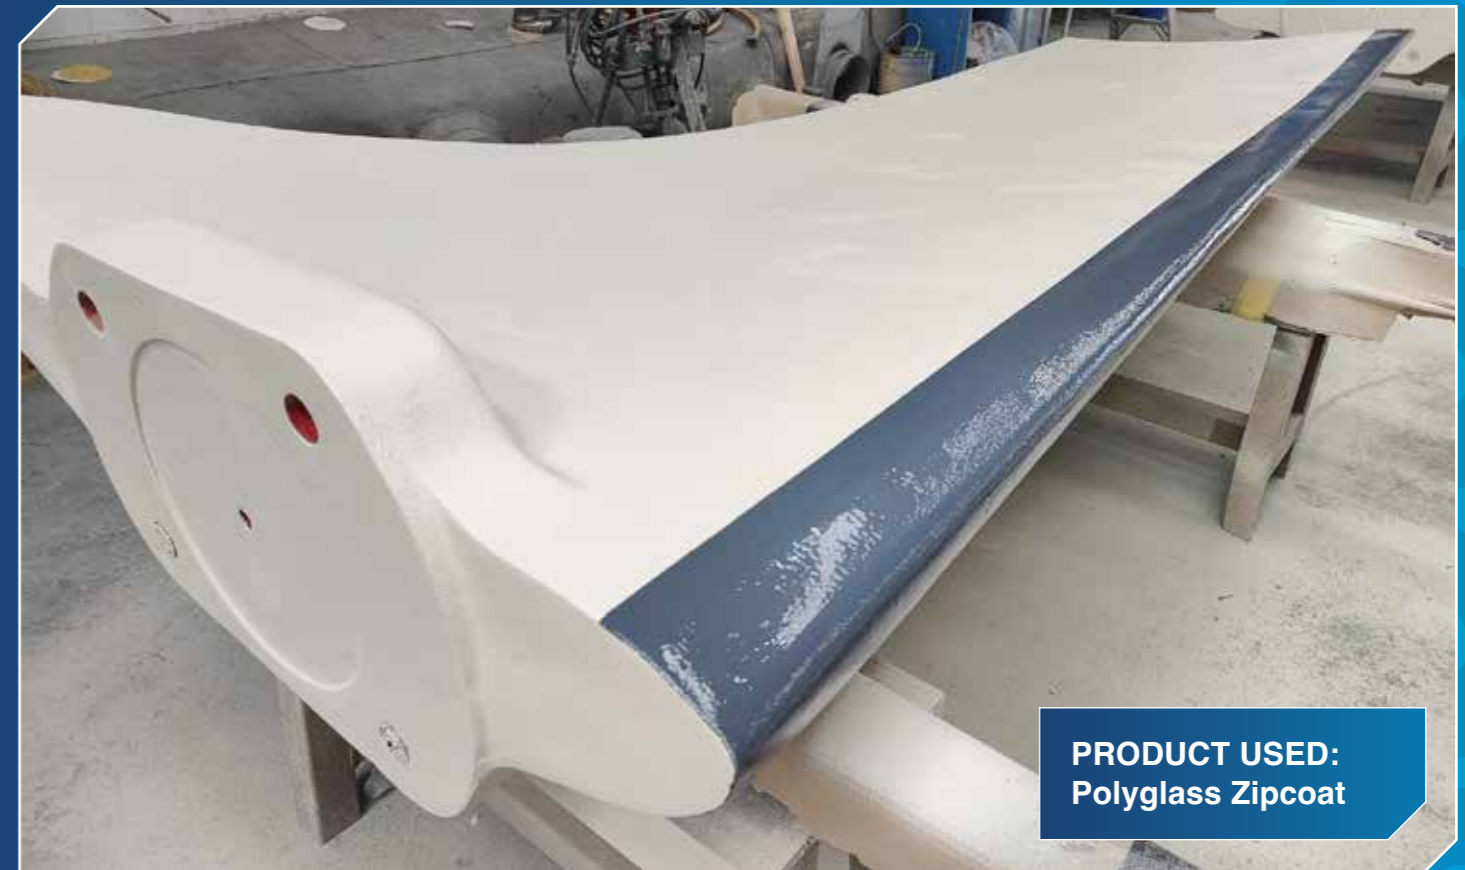
Refurbishment of 8 Cooling Tower Fan Blades

Corroserve were commissioned by a UK gas-fired power plant to repair and protect multiple sets of cooling tower fan blades. These fiberglass reinforced polymer (FRP) blades had been in operation for over 25 years and showed visible signs of wear and damage.

The blades were abrasive blasted to expose and remove any weak material and to provide a surface profile, then a low viscosity primer was applied to consolidate the surface and aid adhesion. Polyglass Zipcoat, a Polyester glassflake coating system, was applied to repair and protect the substrate. Additionally, Rezeroct brushable ceramic was applied to the leading edge for extra protection against surface abrasion and wear.

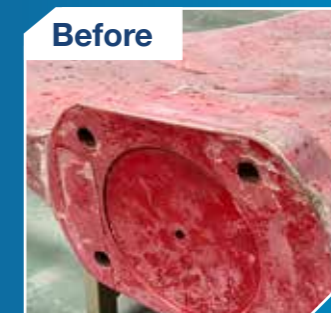
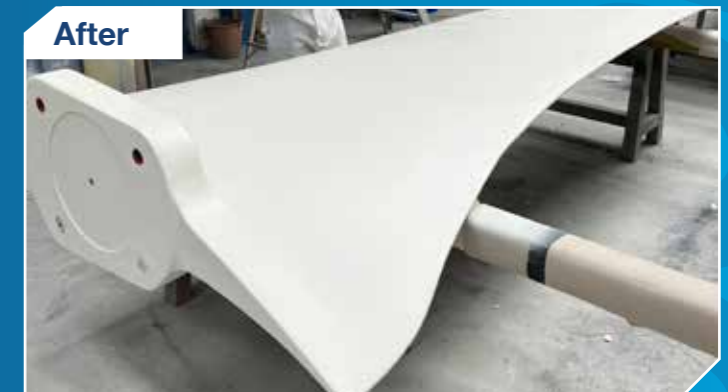
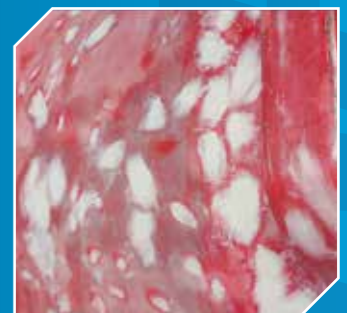
Before

After

After completing the final balancing of the blades, they were recommissioned in June 2024, with an extended life expectancy longer than that of the original blades.

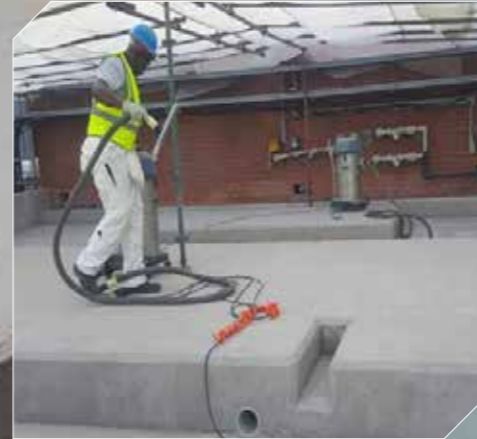
Condition of the concrete after abrasive blasting.

After application of 1st coat of Plasmet ECP Primer.

Following an abrasive blast clean & vacuum of the concrete surfaces, a 1st coat of Plasmet ECP (Epoxy Concrete Primer) as a concrete penetrant was applied. This was followed by application of Corrofill-E (putty-grade building compound), to concrete surface.

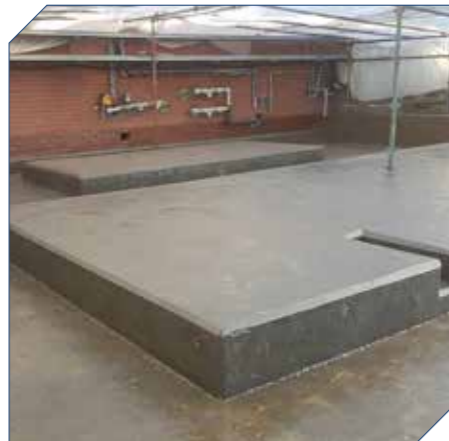
Following application of Corrofill E.

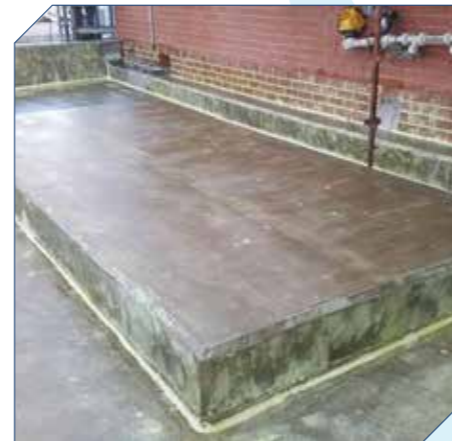
Application of 2nd coat with C-Glass fibre laminate.

A 2nd coat of Plasmet ECP was then applied in conjunction with 25g C-Glass fibre tissue laminate for increased structural stability and to minimise the potential for shrinkage during polymerisation.

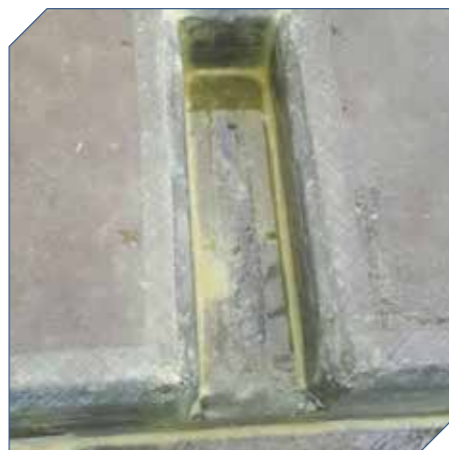
Application of Plasmet AR3 in progress.

Finally, there was an application of ± 4100 litres of Plasmet AR3 solvent-free Epoxy, designed for immersion in 98% Sulphuric Acid. Total Dry Film Thickness: 1500µm average DFT.

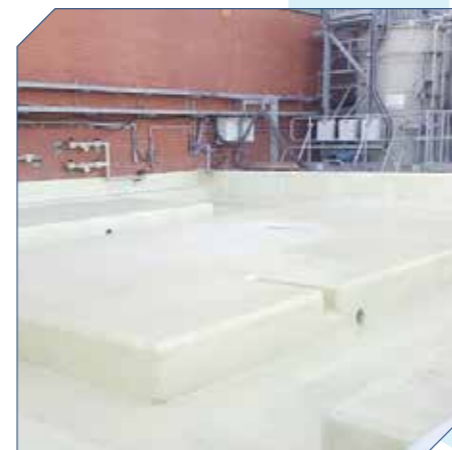
After application of Plasmet AR3.

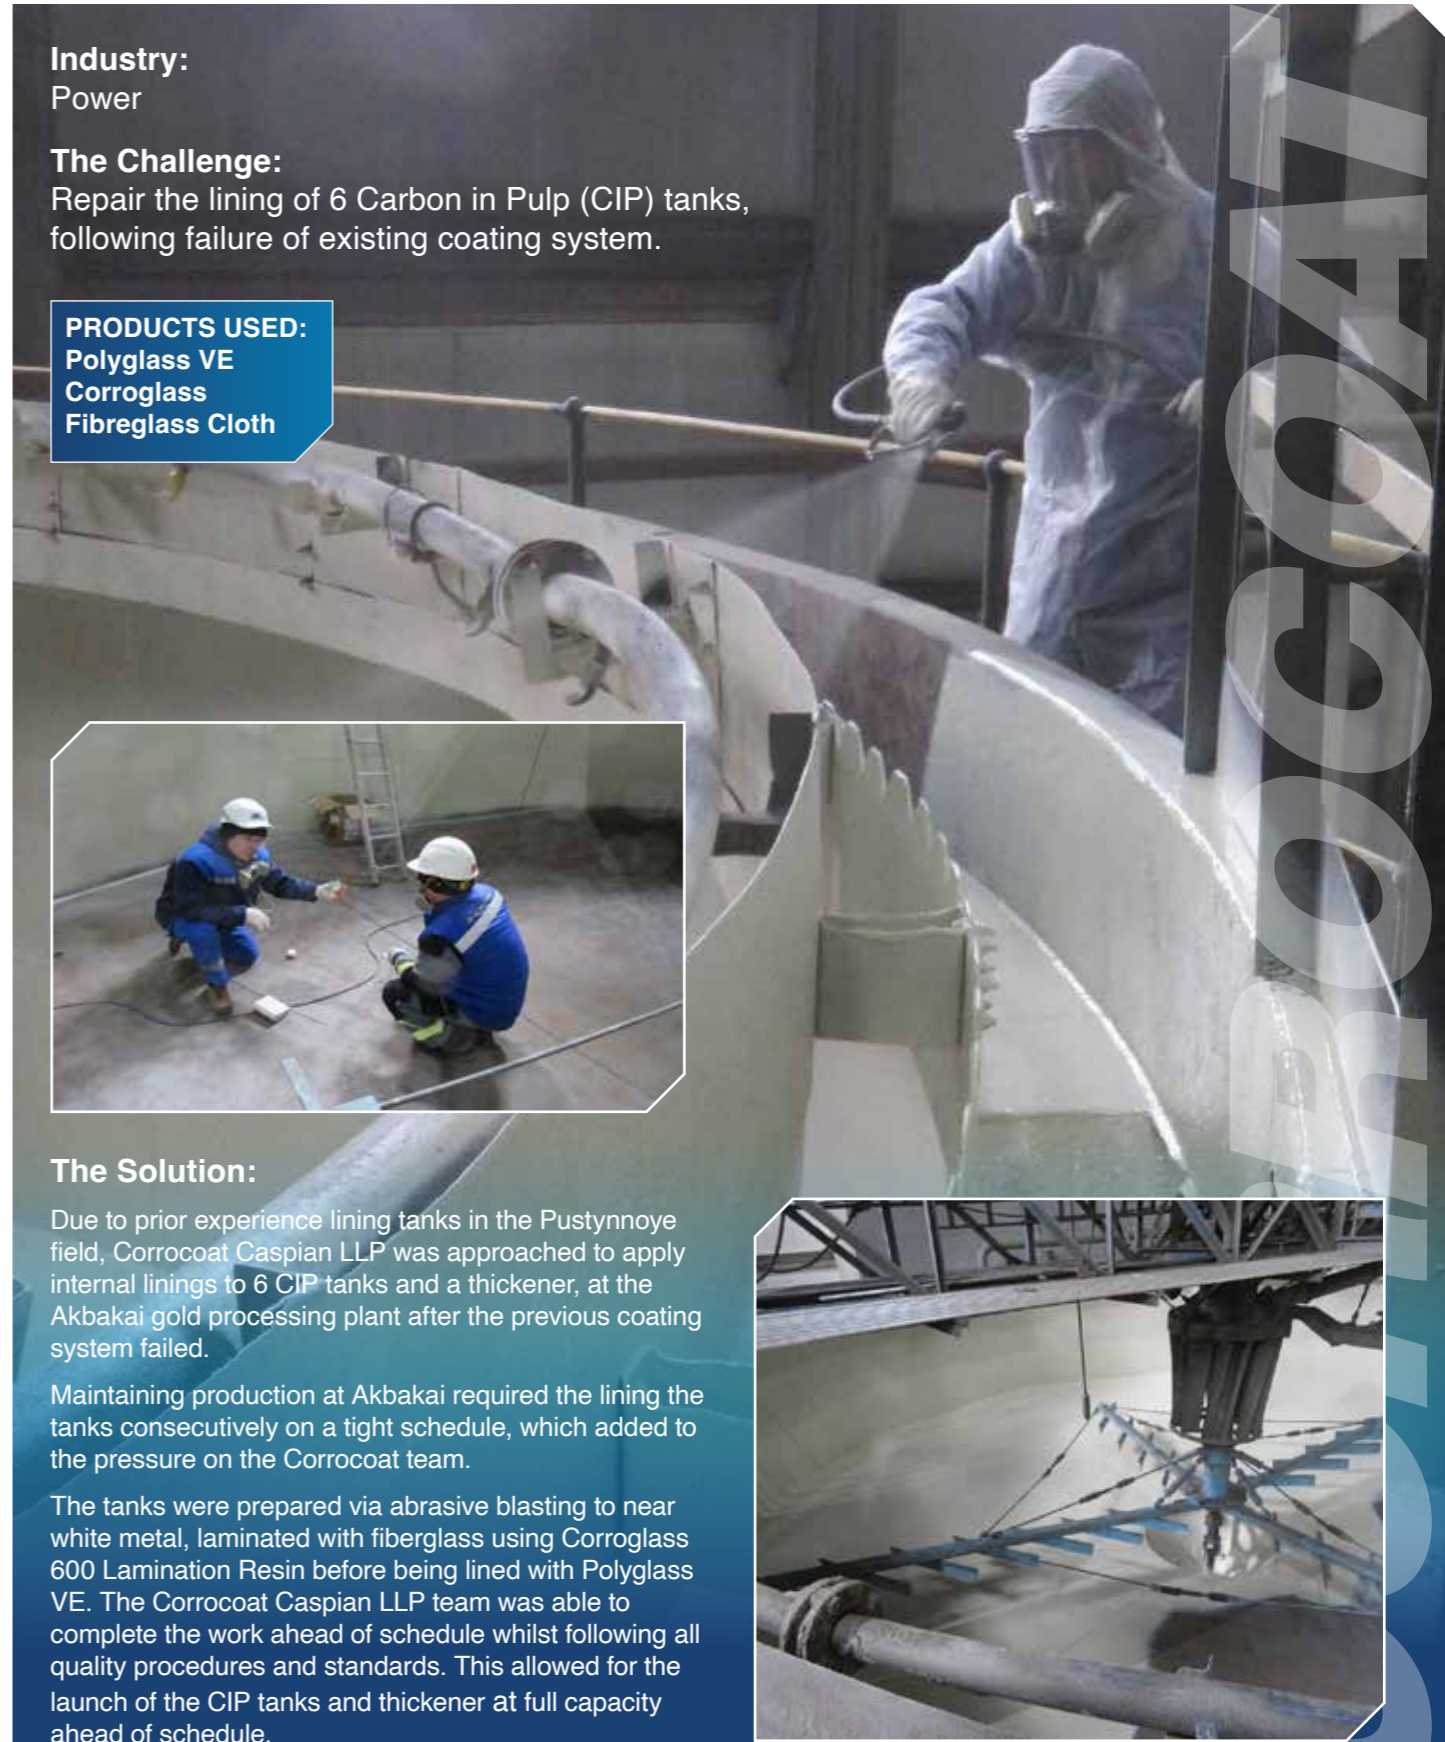
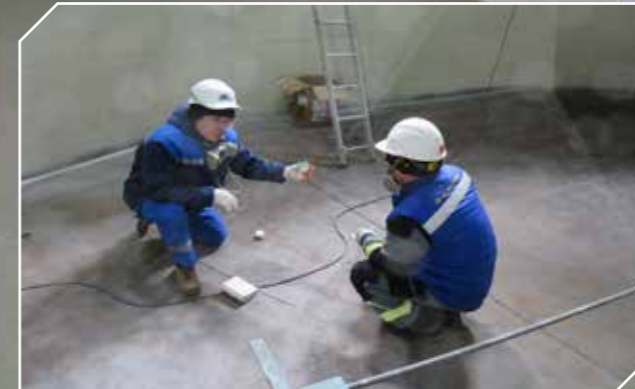
The Challenge:
Repair the lining of 6 Carbon in Pulp (CIP) tanks, following failure of existing coating system.

The tanks were prepared via abrasive blasting to near white metal, laminated with fiberglass using Corroglass 600 Lamination Resin before being lined with Polyglass VE. The Corrocoat Caspian LLP team was able to complete the work ahead of schedule whilst following all quality procedures and standards. This allowed for the launch of the CIP tanks and thickener at full capacity ahead of schedule.

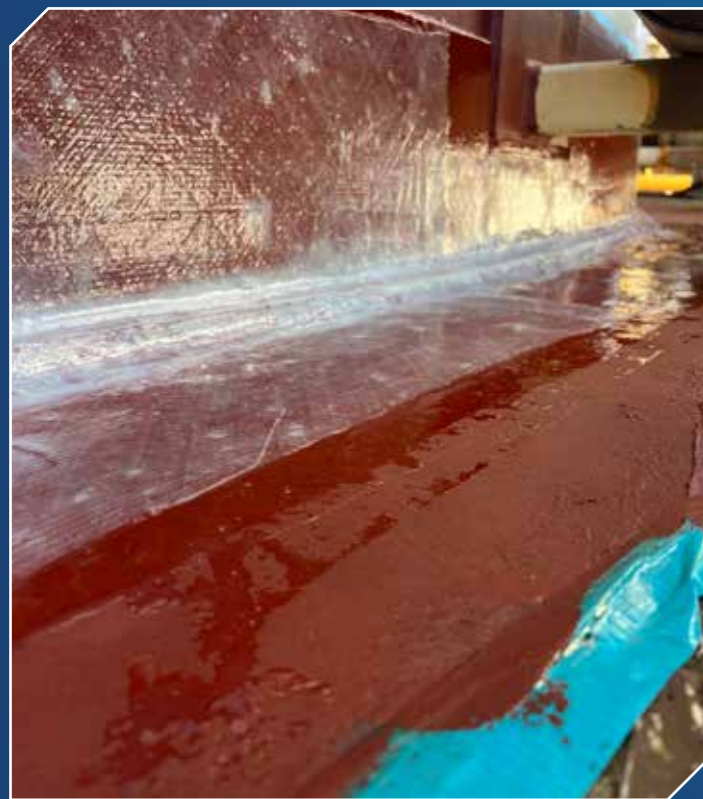
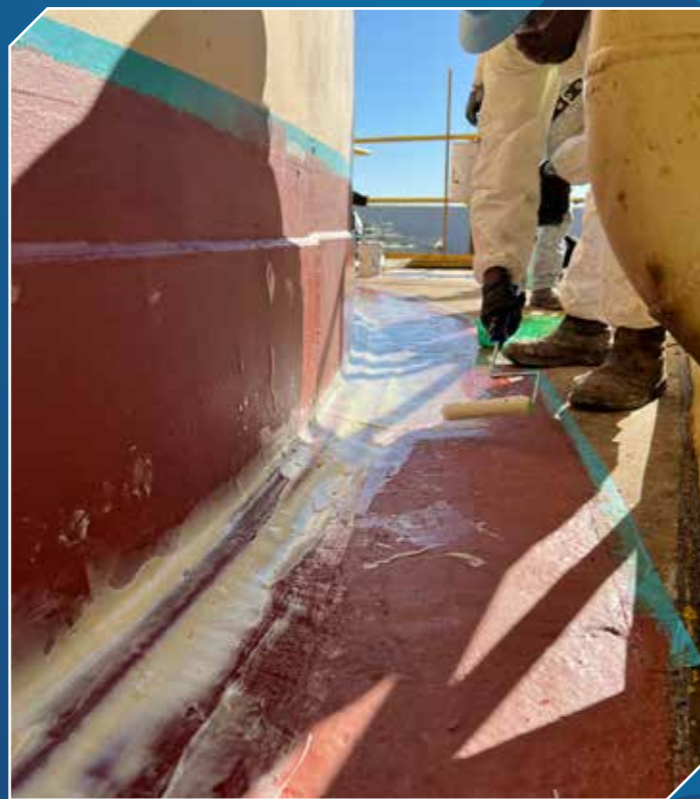
The Challenge:
An engineer from a power plant in Florida contacted Corrocoat USA to look at two of their coal ash silos that had two different types of failed external wrapping systems. These were located at the base of the silo (which was 90 foot (27.4m) off the ground, causing a cavity that could have allowed valuable coal ash to weep from the bottom of the silo and into the atmosphere.

Upon inspection, on Silo #1, the rubber liner was damaged in multiple locations and was leading to concrete deterioration and crevices

On Silo #2, there was a polymer liner that failed at the seam, thereby allowing an ingress of moisture and escape of coal ash.

Corrocoat's Sales Engineer arrived on site within a week of the call. One week after that, a plan was devised for the removal of each of the failed wraps, using pneumatic tools, working a portion of the surface from 125 foot (38.1m) using manlifts. The steel substrate was primed using Plasmert ZF, whilst Plasmert ECP was used for the concrete. A layer of multiaxial fibreglass followed and then finished off with an additional coat of Plasmert ZF and a polyurethane topcoat for UV protection.

An unexpected problem occurred whilst filling holes with the Corrofill E; there were hundreds of holes ranging from the size of a pinhead to the diameter of a walnut.

Although the silo was said to be depressurized during the operation, the shape and size of the silo created a natural draft and therefore pressure on the silo.

After filling about 80% of the holes, the pressure increased on the remaining cavities to the point that pinholes formed in the Corrofill E once placed. It took several passes and significant skill and patience to finally stop all of the air from escaping and fashion the filler to a shape that would allow for effective fiberglass application.
