**CORROCOAT**

# news

June 2026

# HSC PUMP CASING REPAIR & PROTECTIVE COATING APPLICATION

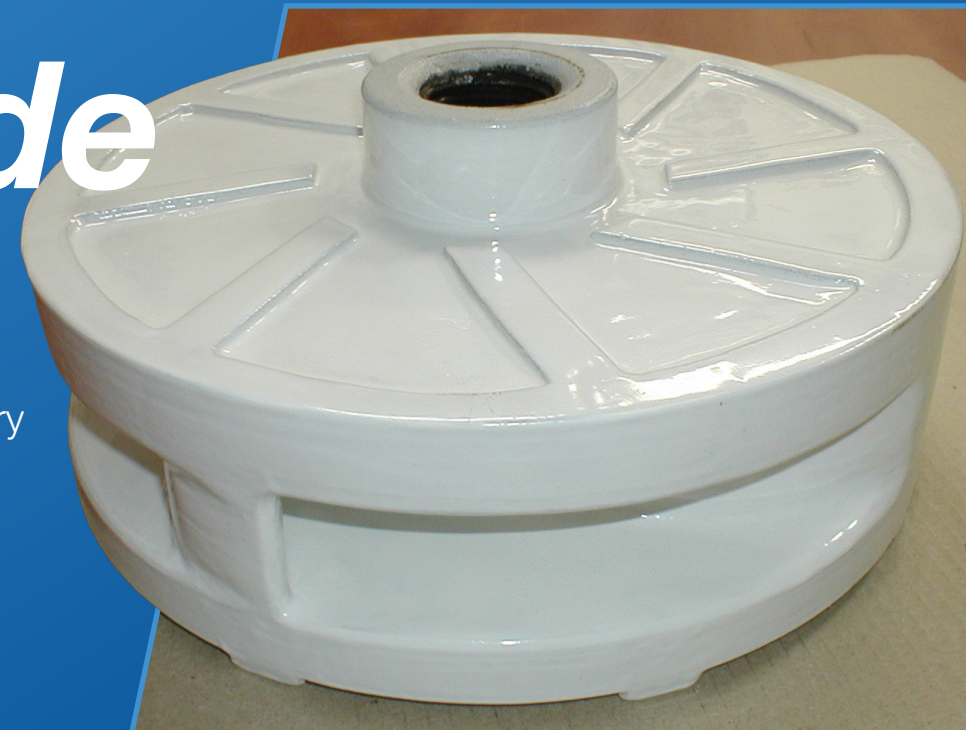
# Fluiglide

Designed to reduce fluid friction and increase flow in the boundary layer. With this, Fluiglide can provide reliable, long-term corrosion protection whilst also reducing power requirements and increased efficiency.

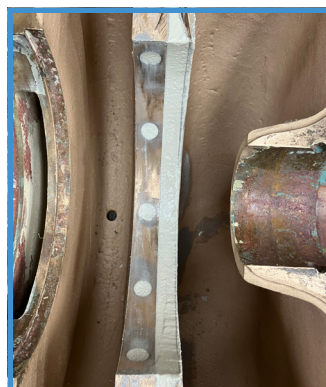
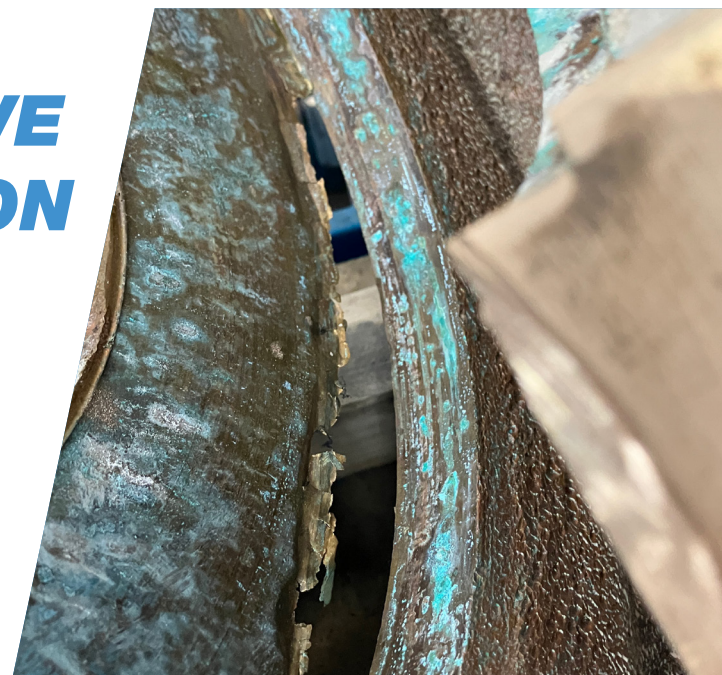
During operation, the pump experienced a bearing failure which caused the impeller to shift within the casing.

This resulted in significant internal damage to the phosphor bronze casing, including:

- Severe wear at the impeller landing areas
- Compromised casing integrity
- Increased risk of reduced efficiency and potential failure
- Given the aggressive nature of the brine environment, a robust and long-term repair solution was essential.

- Installation of phosphor bronze rings in both upper and lower casing halves
- Assembly and precision machining to suit new wear rings, ensuring correct tolerances and clearances
- Rebate machining of upper and lower casing sealing faces
- Abrasive blasting of all internal surfaces to achieve the required cleanliness and surface profile
- Application of multi-directional GRP matting, wetted with L600 laminating resin, to rebuild and reinforce damaged areas
- Full internal coating using Corroglass 600 series, applied to a minimum dry film thickness (DFT) of 1250 microns

- Fully restored casing integrity and functionality
- Improved resistance to corrosion and chemical attack
- Enhanced pump efficiency through correct clearances and surface finish
- Extended service life of the asset in a highly aggressive environment

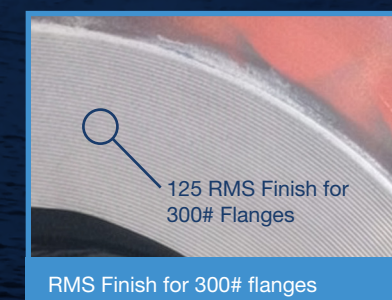
RMS Finish for 300# flanges

- Controlled surface preparation using a combination of vacu-blasting and traditional abrasive blasting within containment
- Installation of former plates and application of release agents to achieve precise casting geometry
- Rebuilding of flange faces using Plasmjet HTE, selected for its high compressive and tensile strength
- Careful in situ application to ensure durability under demanding offshore operating conditions

- Successful restoration of all 94 flange faces in 9 working days
- Successfully passed nitrogen pressure testing following first application
- Returned to service within 24 hours of polymer coating installation
- Prevention of further crevice corrosion and degradation of the sealing surface
- Long-lasting, durable repair suited to offshore conditions
