Urgent Offshore Repair of 94 Flange Faces Affected by Crevice Corrosion

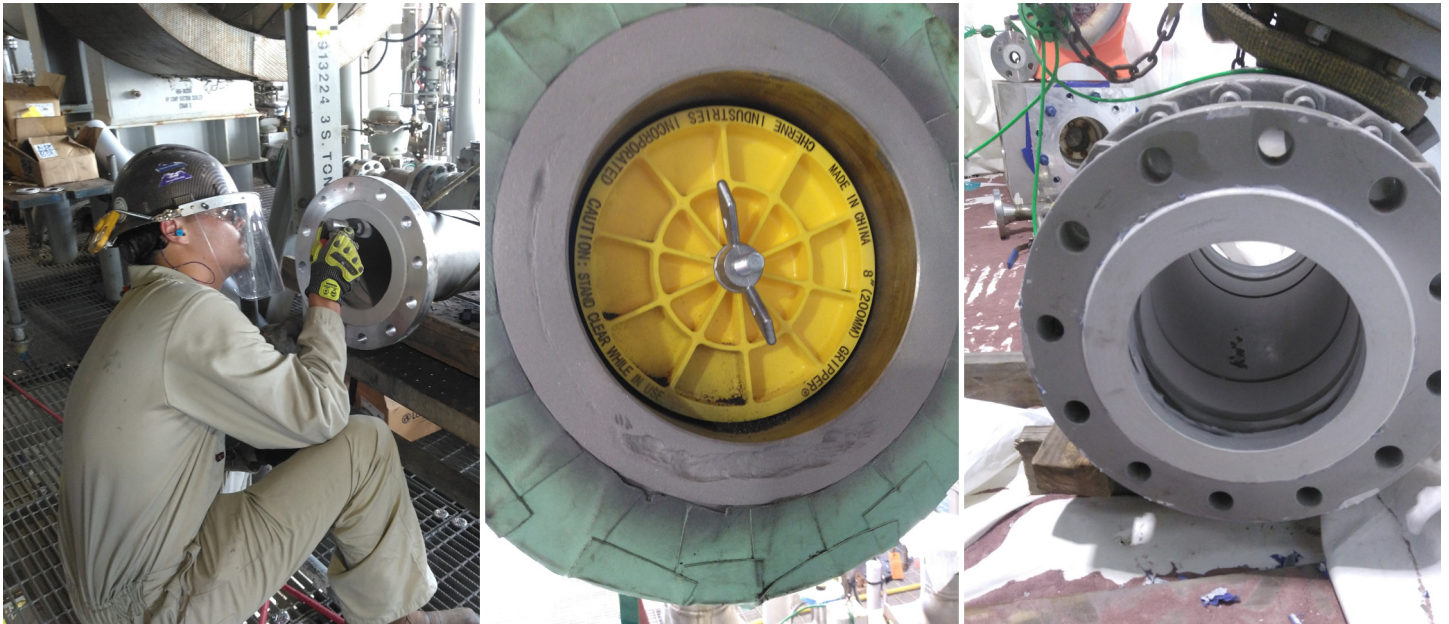
A total of 94 flange faces, ranging from 1" to 8" ID, had developed early-stage crevice corrosion. A previous repair had already failed, leaving the assets vulnerable to further degradation and potential leakage.

Corrosolve deployed a specialist offshore repair team to complete the full programme on-site, utilising a proven flange forming and casting technique.

- Controlled surface preparation using a combination of vacu-blasting and traditional abrasive blasting within containment
- Installation of former plates and application of release agents to achieve precise casting geometry
- Rebuilding of flange faces using Plasmet HTE, selected for its high compressive and tensile strength
- Careful in situ application to ensure durability under demanding offshore operating conditions
