## Case study: Hamworthy pump casing

Holderness Ship Repairers.

Refurbishment and coating of Hamworthy pump casing.

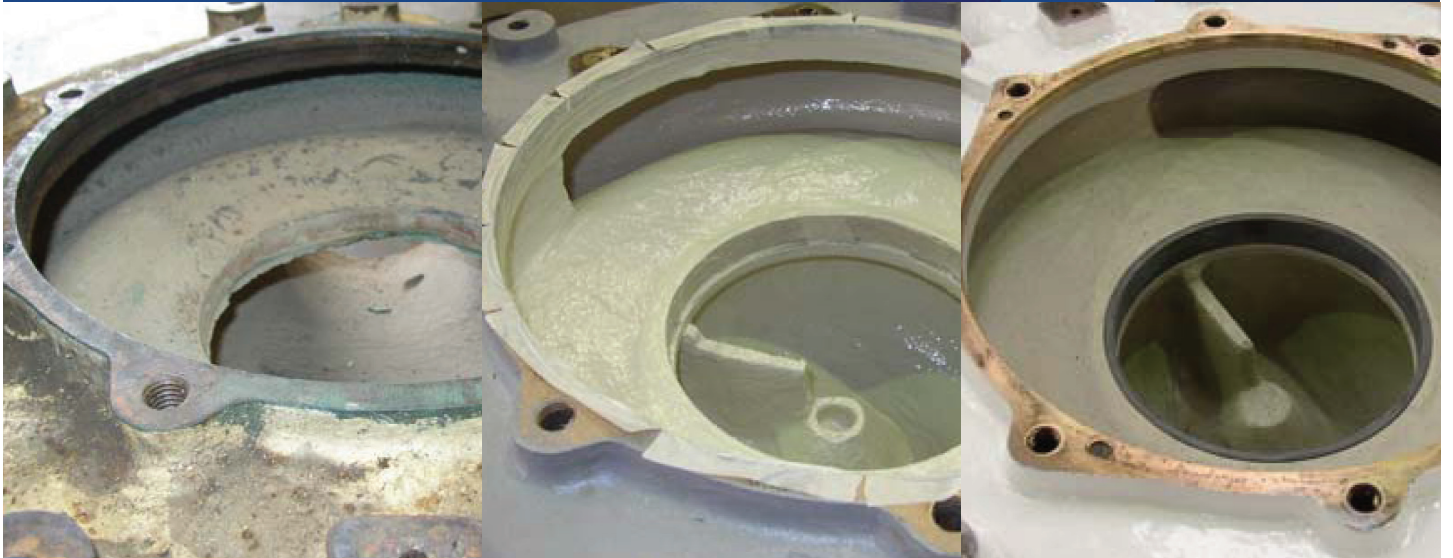
### Photographs

Left: [Hamworthy pump casing on arrival in our works](#)

Middle: [Hamworthy pump casing during coating](#)

Right: [Hamworthy pump casing on completion](#)

- Grit blasted internally to ISO 8501-1 cleanliness standard SA 2½.
- Grit blasted externally to ISO 8501-1 cleanliness standard SA 2.
- Applied internally Corroglass 600 Series to achieve a minimum dft of 1.5mm. Spark Tested and Thickness Checked at 19kv.
- Applied externally two coats of Plasmatec ZF followed by a top coat of Sigmafast Enamel (white).
