Protection from Abrasion

ABRASION PROTECTION PAPER MILL CYCLONES

CORROCOAT

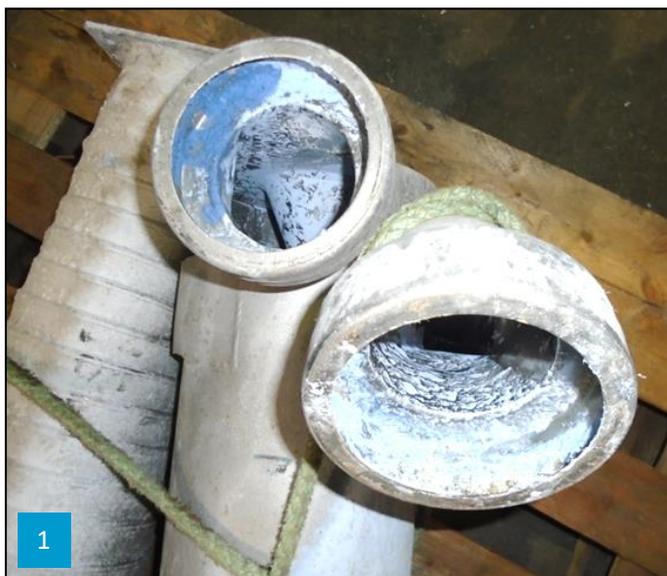
Two cyclones were delivered to Corroserve's workshop in Leeds in need of a programme of repair and onward protection against abrasion. Both cyclones were suffering from severe abrasion damage and both exhibited through wall defects.

1: On arrival at workshops. 2: Through wall abrasion damage. 3: Internal view of abrasion damage post abrasive blasting.

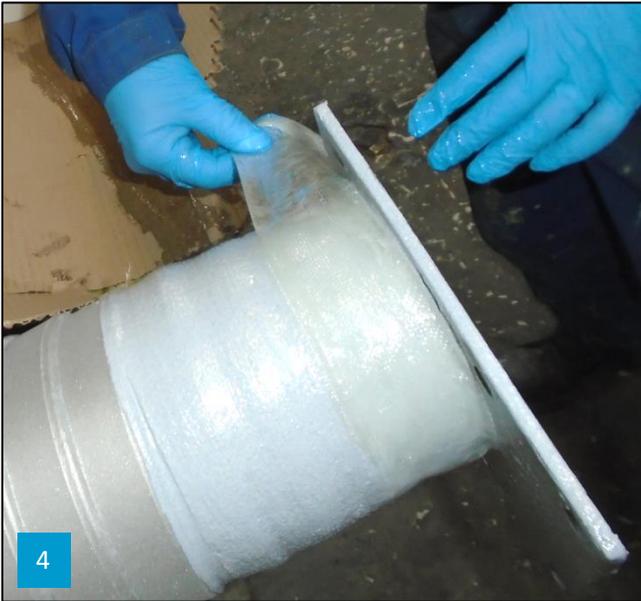
4

4: CSR repair. 5: Coated with Plasmet HTE.
6: Internal coating. 7: Completed cyclones.

Corroserve recommended that after being abrasive blasted to Sa2½ the internal surface be repaired and reinforced using wetted out 300gsm glass fibre matting. After initial cure multiple coats of Plasmert HTE were applied to both internal and external surfaces to reach a required DFT of 2000 microns.
