Case study: Corrosion Protection for Water Vessel

Removing existing lining, surface preparation & Corrosion protection.

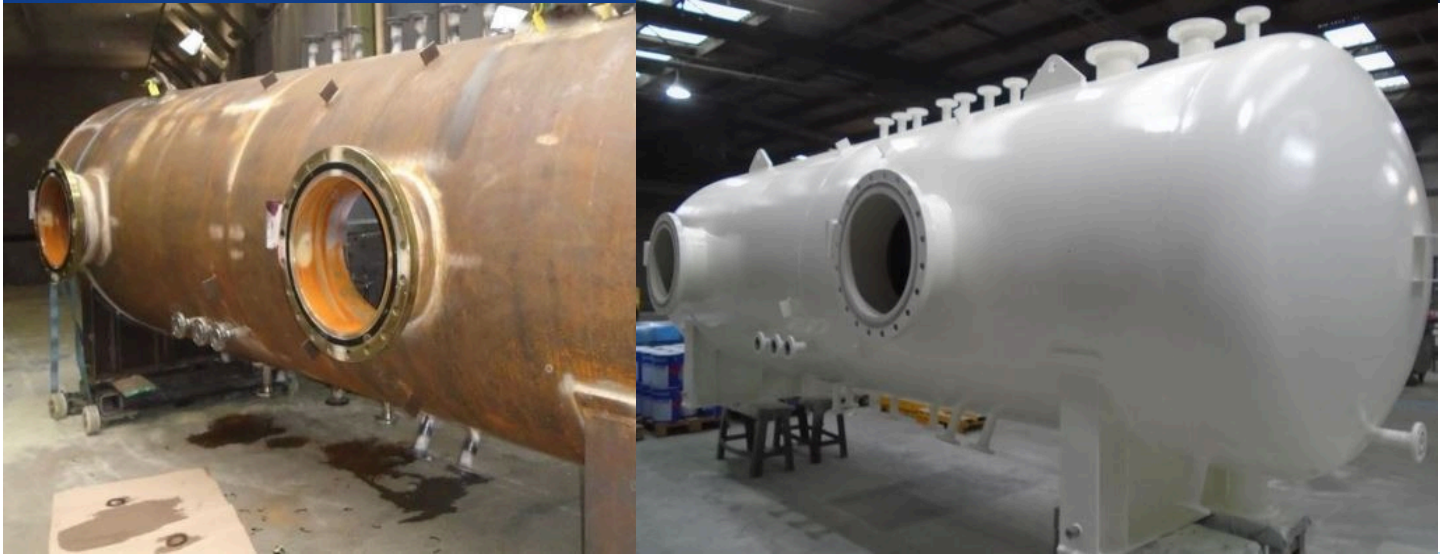
Client requested surface preparation and corrosion protection of a 6.5m long x 1.9m diameter produced water vessel. The 2mm thick lining had multiple failures, mainly around the nozzles and bottom 3rd of the shell.

- Abrasive blast to ISO 8501-1 SA 2½.
- Prime prepared internal surface using Polyglass PPA primer to a minimum surface profile of 50 microns.

- Applied multi-axal glass fabric to the bottom 3rd of the vessel and any nozzles requiring additional protection. The matting was wetted with L600 laminating resin and rolled in to place to remove any trapped air and aid adhesion.

- Applied polyglass VEF to achieve minimum DFT of 1250 microns.

- Abrasive blast to external surfaces with new abrasive in accordance with ISO 8501 - to Sa2 surface finish profile of 50 microns.

- Two coats of Plasmet ZF and a single top coat of Corrothane AP1.
