A Message From Our Managing Director

Stoplog Gate Corrosion Repair for the M.O.D

Corroglass Treatment of MCW Pump Impeller

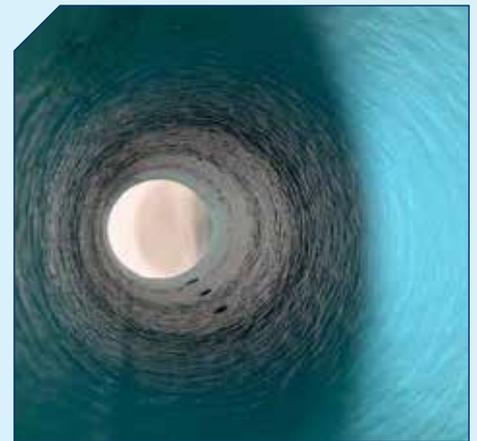
Corrocoat Fibrecoat is a glass fibre reinforced vinyl ester glass-flake coating, developed for use as a high-performance lining and rehabilitation material for thinned/corroded pipes and where additional properties are required.

Designed to be applied by the Corrocoat Agmec airless spray equipment, recent modification to the Agmec small bore pipe sprayer now allows the material to be successfully applied in pipe diameters down to only 150mm in diameter.

The product has great structural properties for a severely damaged pipe, Fibrecoat will create a pipe within a pipe.

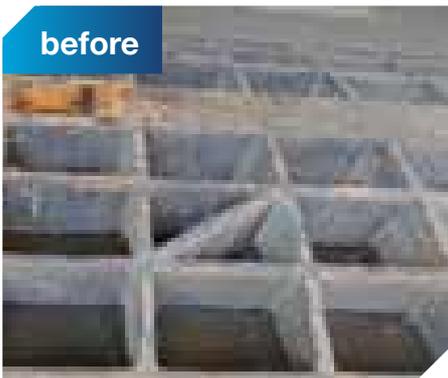
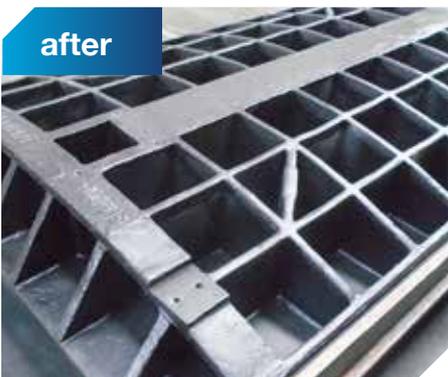
Stoplog Gate

Corrocoat UK recently won a contract with the Ministry of Defence to provide corrosion protection for 2 stoplog gates, 53 brackets and 2 column pipes. The equipment would be subject to salt-water conditions at ambient temperatures, therefore the coating system used, required excellent resistance under aggressive immersed conditions.

Firstly, the bronze trim and any areas not requiring coating application were masked to be protected. Abrasive blasting of external surfaces in

accordance with ISO 8501 – 1 Sa 2½ surface cleanliness was carried out to achieve a minimum surface profile of 50 microns. A final blow down, sweep and thorough vacuum clean was then completed to remove any dust, and finish the preparation of the equipment ahead of coating application.

Polyglass VEF (black) was applied to the minimum DFT to 1250 microns to all of the internal surfaces. This was done via airless spray with relative humidity <85% and steel temperature 3°C or greater than the moisture dew

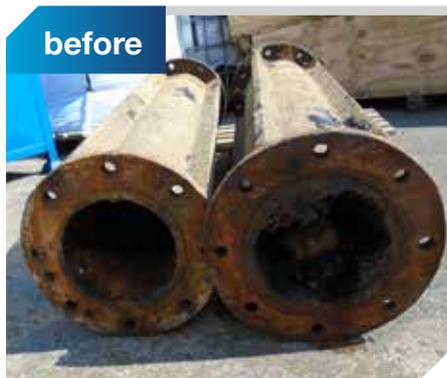
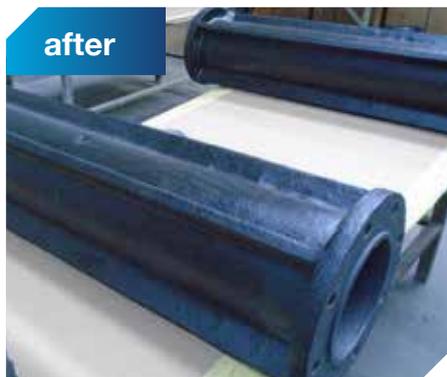
Column Pipes

point. A single coat of Plasmert ZF was applied to the externals of the two column pipes, and thickness testing and spark test at 17kv, following the adequate cure of the coating.

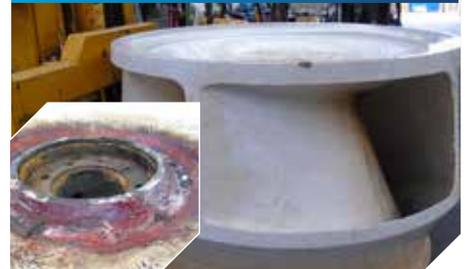
Impeller Before Repair

The pump was returned for maintenance and repair, and despite 15 years of service operating in water with high sand content, the damage to the impeller was impressively minimal, with just a few areas of mechanical damage and slight water damage and discolouration along the vein tips and edges.

Also, following the blasting process, the ring element of the pump was found to be severely damaged. In order to address this, the impeller was returned to Sulzers and a new stainless-steel ring was applied to add additional protection to this part of the component and limit future damage.

To begin, the impeller was flash blasted with fine grade abrasive. A fine grade was selected to avoid damaging the original coating, which had remained in excellent condition. Once clean, the surface was 100% spark tested to

identify any damaged areas. DFT's were taken all around and found to be around 1.5mm, which was the original specified thickness. There were 8 small damaged areas in total, which were blasted to Sa 2½ cleanliness and a surface profile of 50 microns.

They were then repaired with Corroglass 600 series, using 632 to prime the bare steel and then 602 was applied in multiple coats to build up to the required thickness and re-profile to the existing coating. On completion of the Spark/DFT inspection, a topcoat of 652 white was applied to the full impeller.

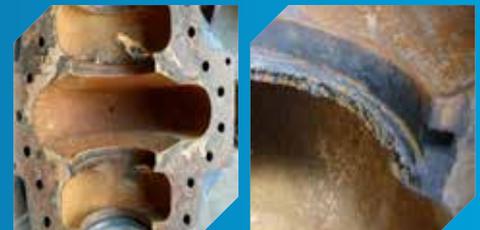
Pump Before Repair

Kahramaa is the sole transmission and distribution system owner and operator for the electricity and water sector in Qatar. They recently required internal corrosion protection of a potable split case pump, which had been in operation for several years. Upon inspection by Alhuda Corrosion Treatments (our partners in Qatar), substantial corrosion was found on the internal pump body, alongside general pitting and metal erosion.

In order to repair and extend the life of the pump, Alhuda Corrosion started with abrasive blasting on the internal pump surface. Chloride testing was conducted before and after the blasting to ensure salt water levels met the required low specification in the substrate, ahead of application. Corroglass Lamination

Resin 600 and multi axial fibre cloth was applied on the pitted and eroded areas, reconstructing and restoring them back to the original size and shape.

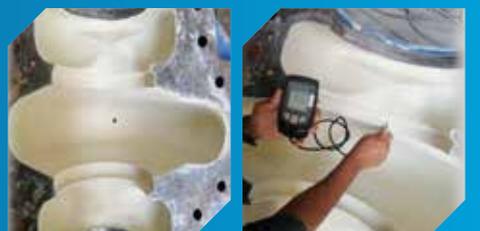
Pump After Repair

Following completion of the lamination process, Polyglass VEF was applied by air less spray to 1000 micron on the internal surface of the pump. Polyglass VEF is suitable for many chemical environments within the full pH range.

A quality control thickness check was carried out to ensure compliance to the written specification with coating integrity assured by a high voltage holiday test. Polyglass VEF will protect the cast iron substrate and offer good resistance to abrasion for many years, considerably extending the service life of the pump.

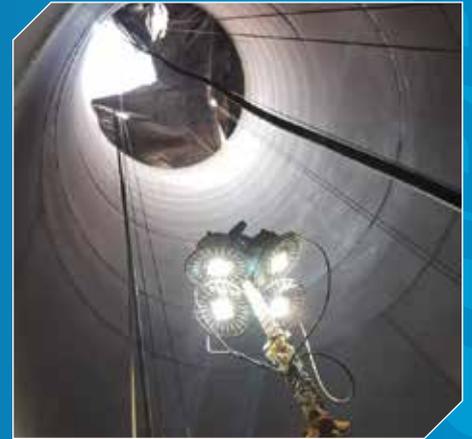
Kirloskar Corrocoat has become the only Indian company to successfully coat the internal surface of a steel chimney stack, standing at an enormous height of 130m. The chimney stack, located at a major refinery in Northern India, was repaired in situ during a scheduled shutdown at the refinery, within a specified timeline of just 28 days.

This full turnkey project required a suspended winch platform to enable the coating team to manoeuvre up and down the chimney internal, whilst carrying out the required work. The team cleaned the internals with high-pressure water jetting, to remove the dust inside. The project was completed during the winter months, with temperatures ranging from

The chimney will be operating without flue gas desulfurization for a few years, at a temperature in the range of 135-150°C and it was confirmed by the client that if the preheater failed, the temperature could rise as high as 300°C for between 15 to 30 minutes. With this in mind, Corrothane XT was the coating system selected for this project. This three-pack cold cured vinyl ester urethane polymer alloy with high performing glass flake is an ideal choice for coating both steel and concrete surfaces, where good chemical and high temperature resistance is required. The coating was manufactured and supplied directly by Kirloskar Corrocoat.

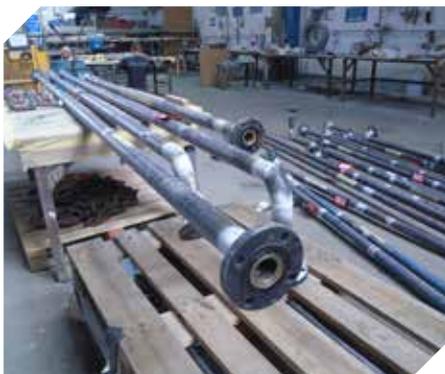
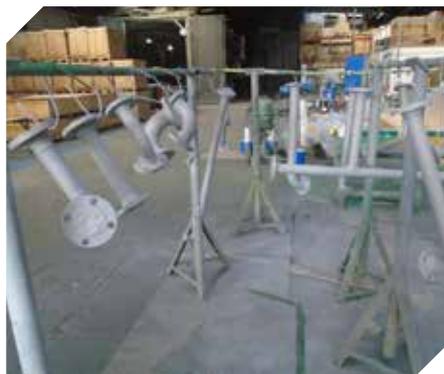
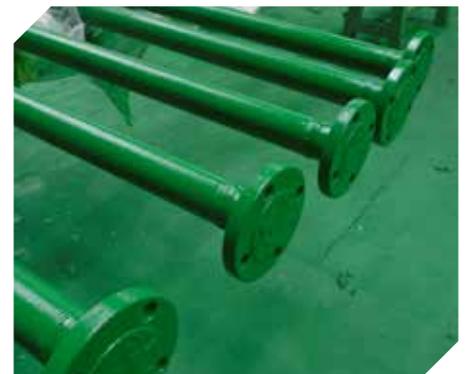
Measuring only 2" in diameter, the internal surfaces of these small pipes were coated with Polyglass VEF. For straight lengths, pipe spinning methods were used to ensure uniform thickness and for any pipes with bends flood and drain methods were used to coat the internal

surfaces. For the externals, the edges were dressed and welds prepared to comply with Corrocoat spec. 6/10, Weld finish, which is extremely important for long term coating performance. The external surfaces were stripe coated with 2 coats of Plasmatec ZF and a single coat of Corrothane AP1.

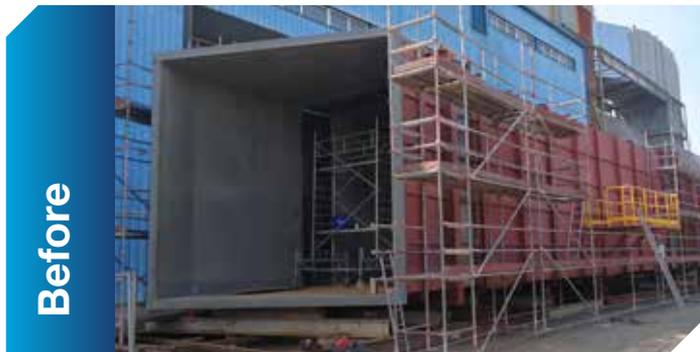
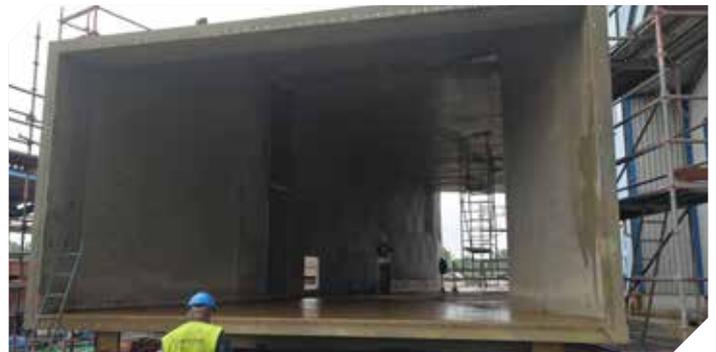
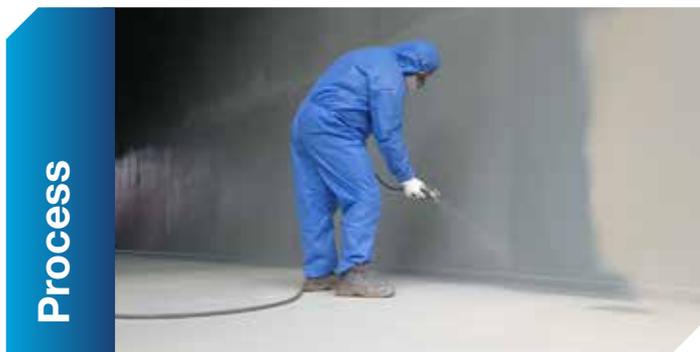
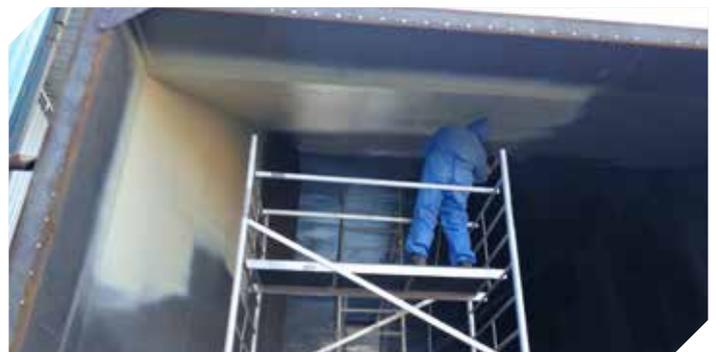
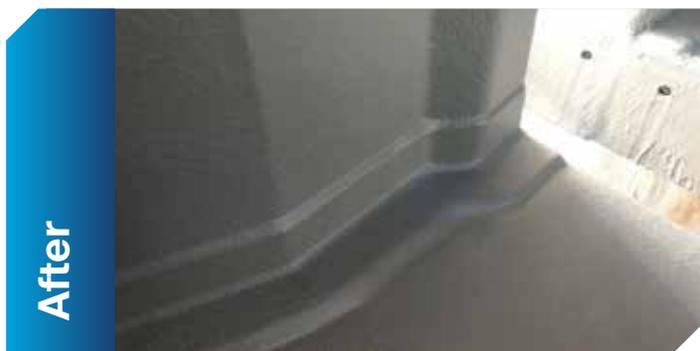
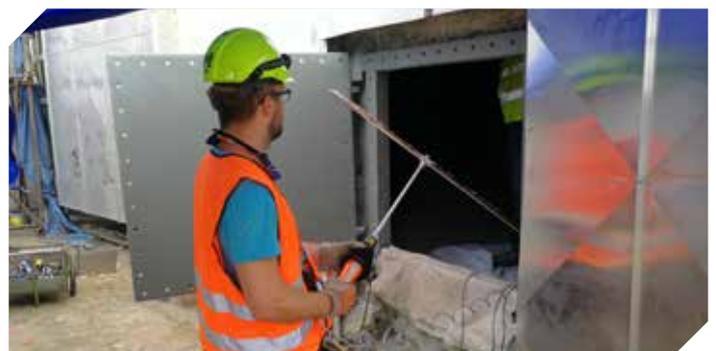
Each carbon steel duct was 630m² and required the removal of coarse sediments as well as the previous coatings and the decontamination of soluble salts from the surface. Following the first stage, surface preparation to ISO 8501-1 with cleanliness Sa 2½, an application of primer Polyglass PPA (our peroxide catalysed, glass flake polyester primer) was applied. The primer was selected to provide sufficient time for the internals of each duct to be blasted and coated.

Stripe coating of Polyglass VEHA was then carried out, with Corrofill VE being used with the paint system to compensate for the unevenness and profiling of all welds. Lamination

Resin 600 and Quadraxial fibreglass cloth 600g/ m² were then applied to the whole surface, covering the fixtures and fittings of the internal surfaces and offering reinforcement to the inner sides of the manways.

The ducts were finished with an application of abrasion resistant Polyglass VEFWR and quality assurance procedures were completed as per the designed inspection and test plan. This project was carried out alongside another job on site to repair and protect an absorber, which was completed by 4 engineers over a period of 8 days.

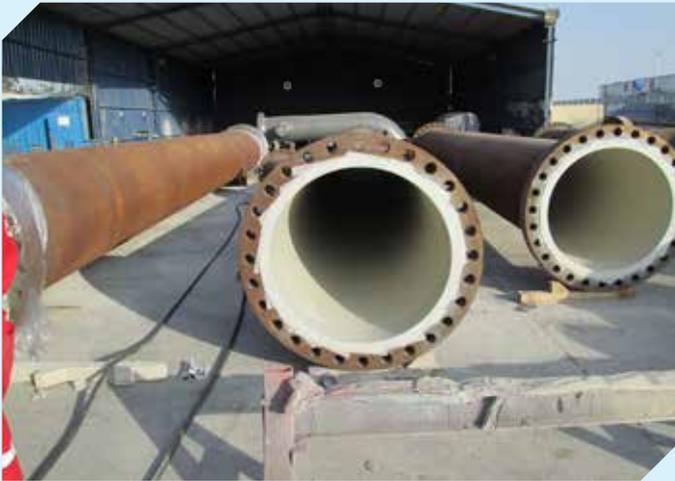
As part of a series of initial projects, a number of pipespools required repair and restoration from corrosion damage at a seawater injection plant. The project ran over 9 months and Polyglass VEF was the primary coating system used throughout. Polyglass VEF was the ideal coating system for this project, protecting the spools from future corrosion damage from seawater and in turn extending their service life considerably.

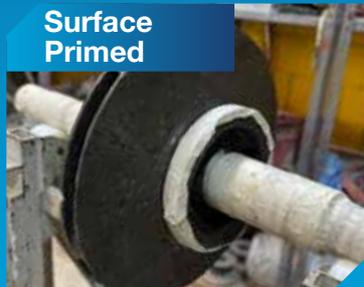
Surface Primed

A petroleum client in Kuwait deemed one of their impellers “unrepairable” due to corrosion from salt water and an accelerated rate of corrosion as a result of extreme hot weather - Kuwait is recorded as one of the hottest countries in the world, with temperatures averaging as high as 54°C. The instruction was given for our Kuwaiti partners, Al-Sabaiea National, to “completely replace it with a new impeller” as the equipment specialist stated it was unrepairable and would not be able to function properly.

With the application of Corrocoat’s Polyglass series, the Corrocoat team were able to refurbish and fully restore the impeller back to working condition, despite the testing weather conditions, which made it extremely difficult for the team to work in the exhausting heat and humidity. When presented to the client the impeller was unrecognizable, almost like new.
