## FLUIGLIDE: 16/14 HSC **PUMP CASING**

## CORROCOAT

#### **Protection from Seawater**

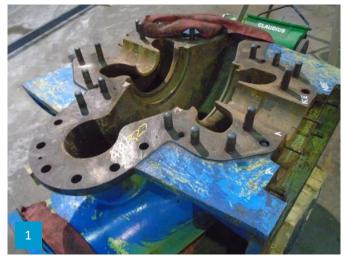
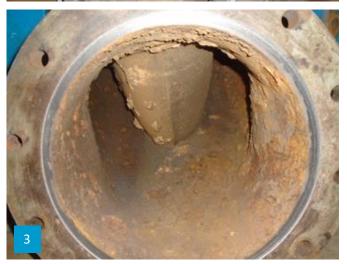
- 1-2: On arrival at works. 3: Internal corrosion.
- 3: Internal lining with Polyglass VEF.

4: Post abrasive blasting.

A 16/14 HSC pump was suffering severe internal corrosion due to salt water service and required refurbishment and ongoing corrosion protection. As well as protection against corrosion the client also wanted to achieve an increase in the pumps operating efficiency.

The internal surface was abrasive blasted to Sa2½ and thoroughly cleaned down to remove dust and debris. A first coat of Polyglass VEF was applied to a DFT of 800µm and when cured a top coat of Fluiglide friction reducing coating was applied to a final DFT of 1250μm.

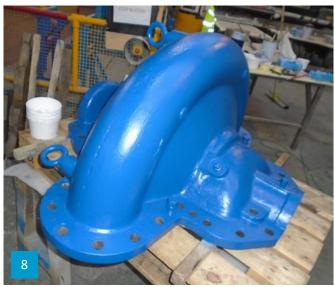
# 6

5: First coat Polyglass VEF. 6: Top coat Fluiglide.
7: Internal lining. 8: Externals coated with Plasmet ZF and top coat of enamel.

In order to provide all round protection the external surfaces of the pipes were coated with Plasmet ZF, a surface tolerant coating, before a final coat of enamel was applied.
