Revitalised Impeller Performance: Overcoming Heavy Erosion and Pitting

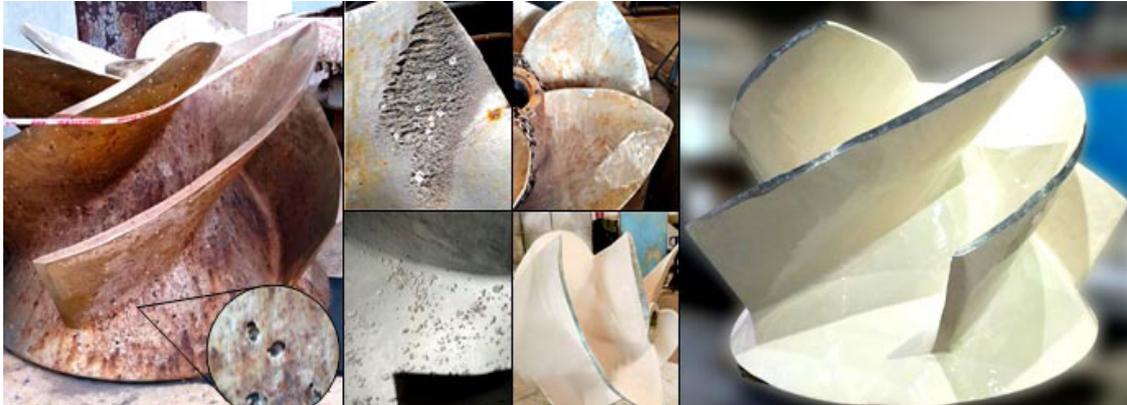
In the dynamic engineering landscape of a thermal power plant nestled in South Eastern India, a critical challenge emerged. The super duplex SS impellers of the vertical turbine pumps (Flow rate - 45,500 M³/ Hr), vital for the plants circulating seawater system, began to show signs of wear and tear after 12 years of service. Heavy erosion and pitting threatened the efficiency and reliability of these essential components, jeopardising the plant's operation.

Utilising engineering techniques and specialist coatings, KCPL refurbished the impellers, ensuring not only the refurbishment of erosion and pitting but also protecting against future wear. The result? A rejuvenated lifespan for the impellers, increased performance, and substantial cost savings for the client.

The impellers were dynamically balanced following mechanical repair and re-profiling, and following the surface preparation and coating to ensure optimum performance.
