Reinforcement for Y Pipe

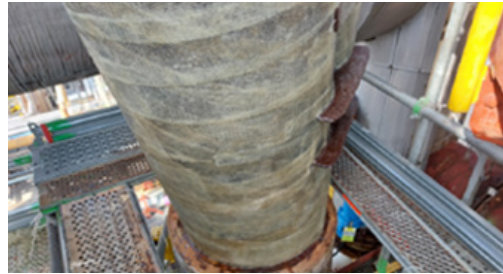
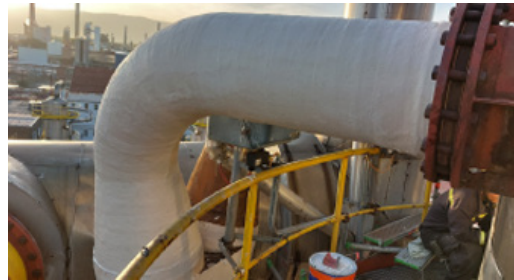
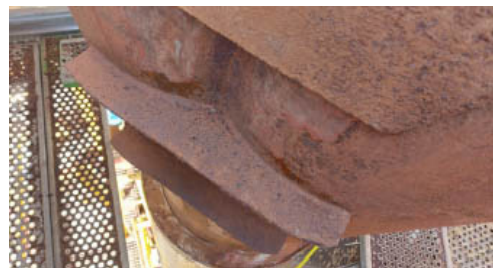
A client at a petrochemical plant in the Czech Republic required reinforcement of a carbon steel 500mm diameter pipe, spanning 16m². The pipe was part of a refinery tower, transporting nitrogen, and was suffering from corrosion under insulation, which compromised the thickness and integrity of the substrate, in certain areas.

The complicated shape/'Y' nature of the pipe, posed a challenge in terms of the wrapping of the lamination cloth, which the team effectively navigated. The team also had to carry out the work and take extra precautions with the wrapping aspect, as a result of the nitrogen continuing to run through the pipe, with a surface temperature of 70°C. Polyglass VE was applied by hand, and the work was then tested and assured as per the designed inspection and test plan.

It took the team 4 days to complete the project in-situ. The first step was to clean the corrosion deposits, this was done via hand tools, before priming with LR600. Four layers of multiaxial fibreglass cloth were then applied to provide strength and reinforcement to the pipe.
